Infiltration BMP Design and Maintenance Optimization

Preliminary Results

Lake Tahoe Basin Science Conference

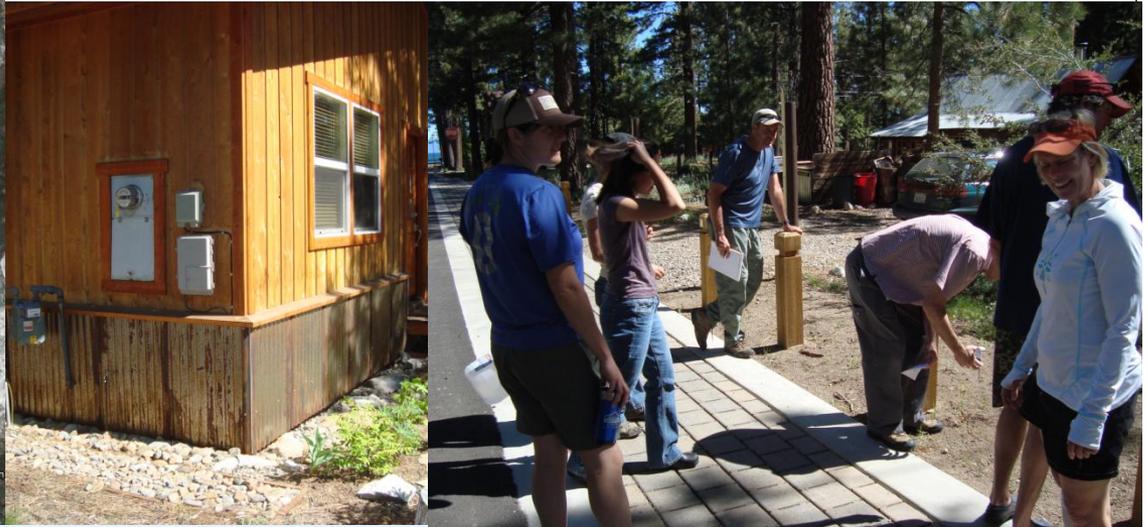
- Concentrated in the South Lake area
- Coordinated with TRPA and landowners
- 45 Sites
 - 45% Single and Multi Residential
 - 45% Commercial
 - 10% other

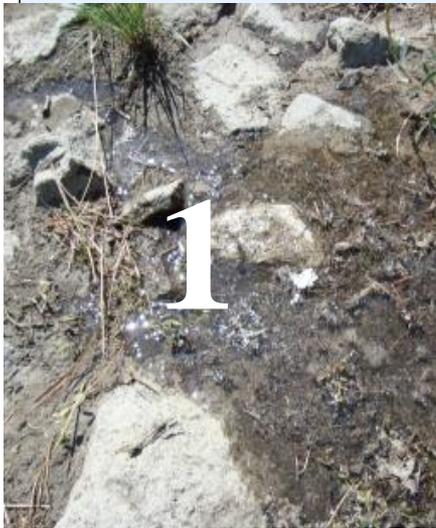
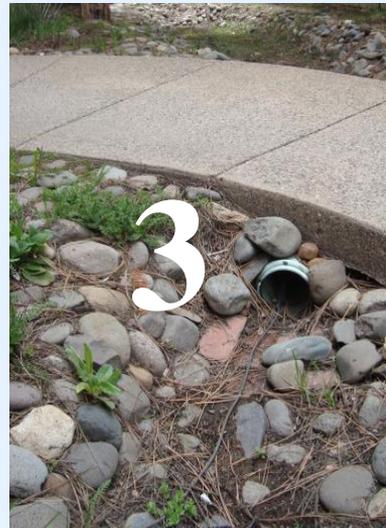
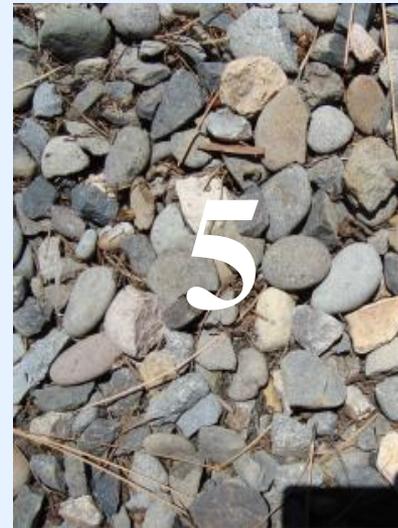
Condition: Visual estimate of sediment accumulation

- Visual condition estimate is a poor indicator of performance
- Non-design runoff results in severe declines

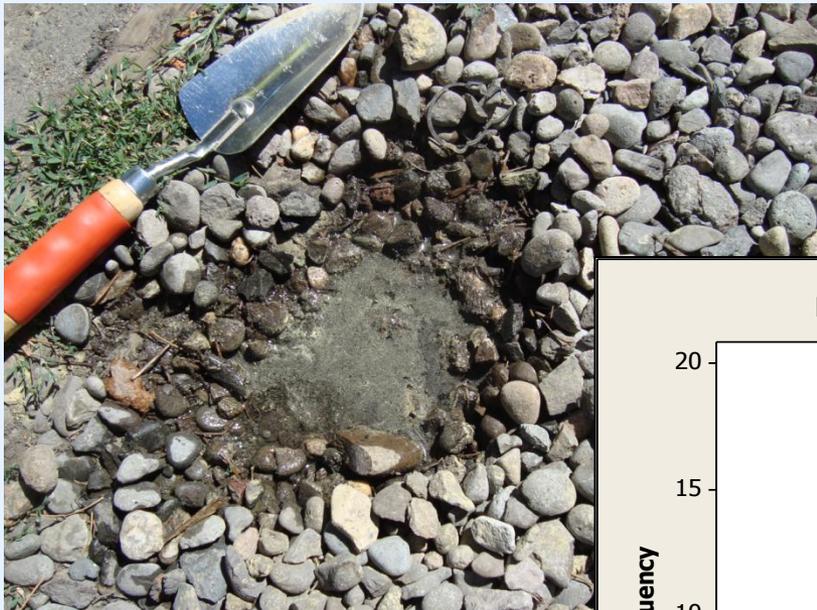
Drainage Surface and Infiltration Performance

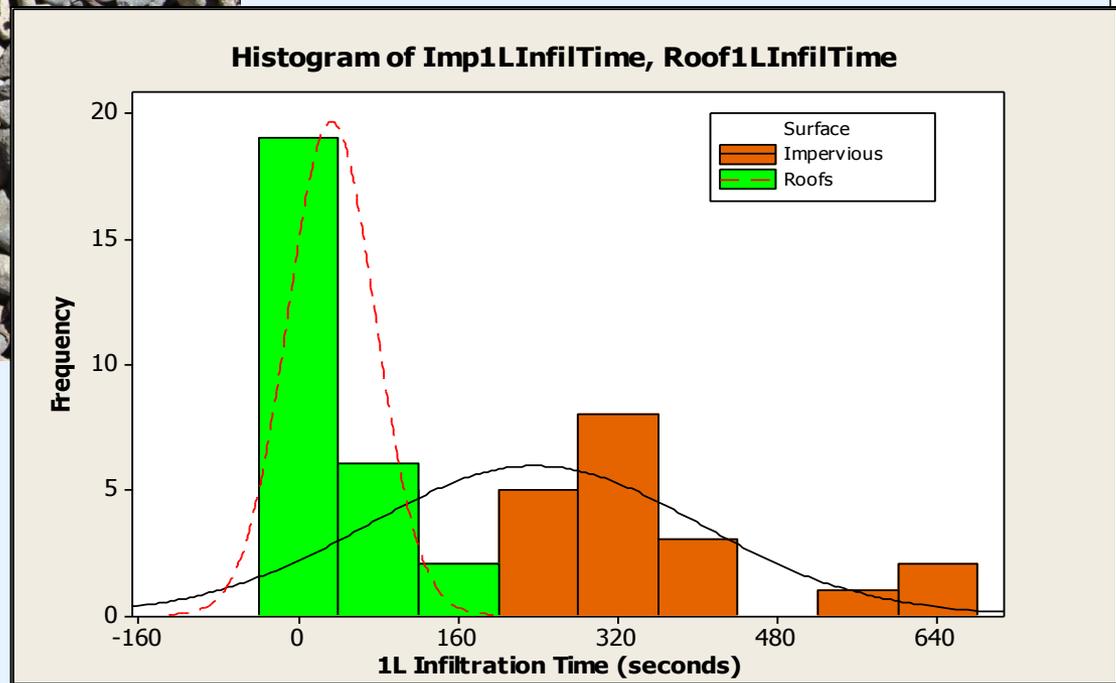
Performance diagnostic - time for infiltration of 1L water.

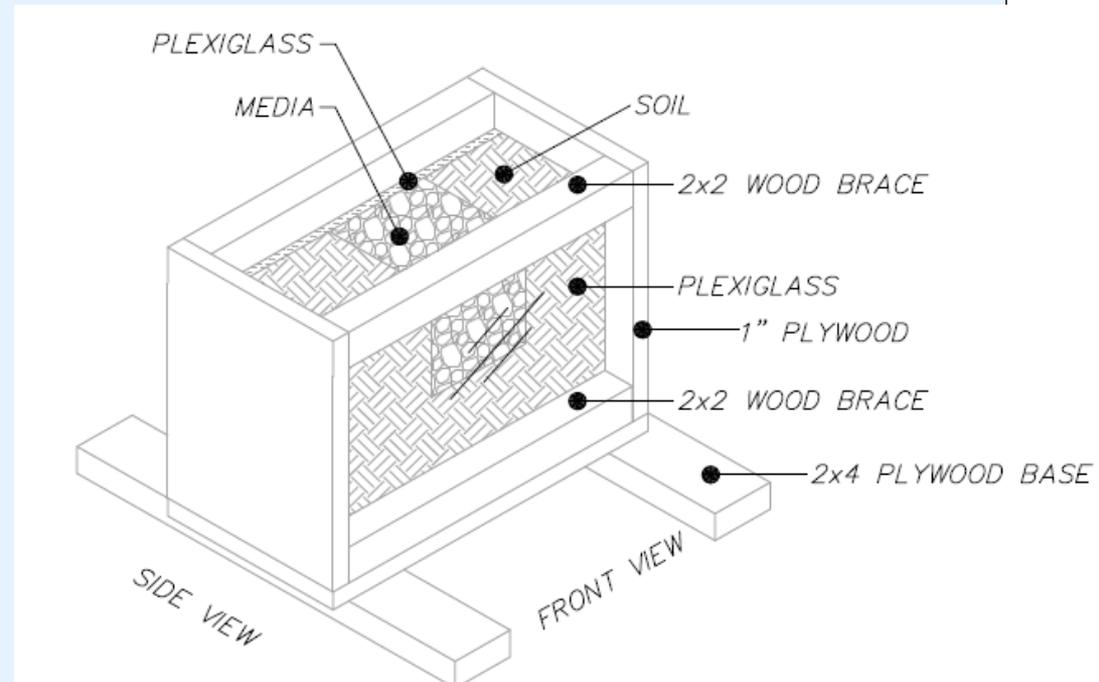
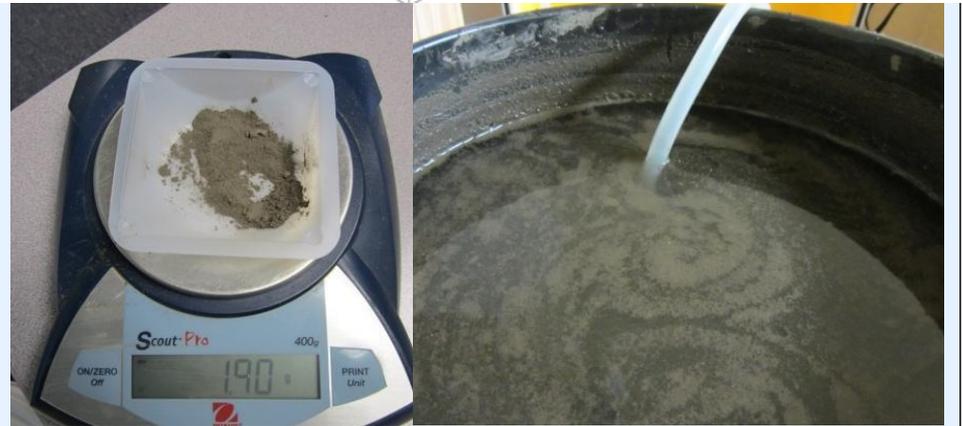
- Load stormwater with typical Tahoe Basin FSP mg/L
- Vary stormwater composition and BMP designs
- Quantify infiltration performance changes

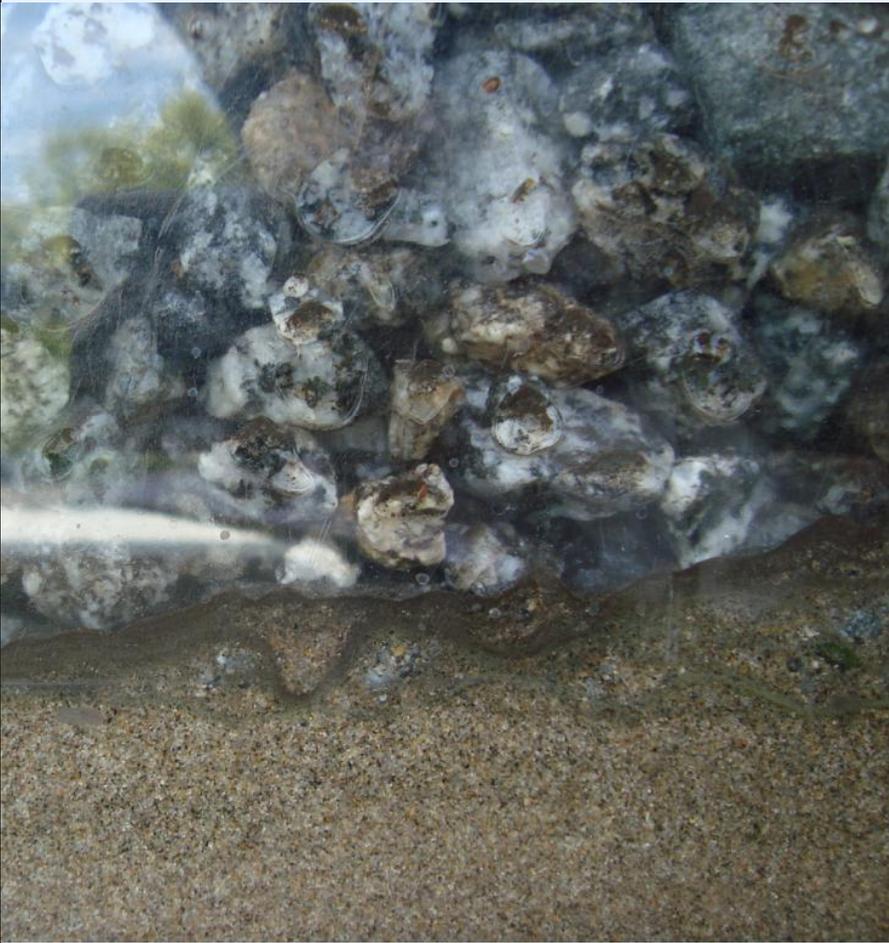
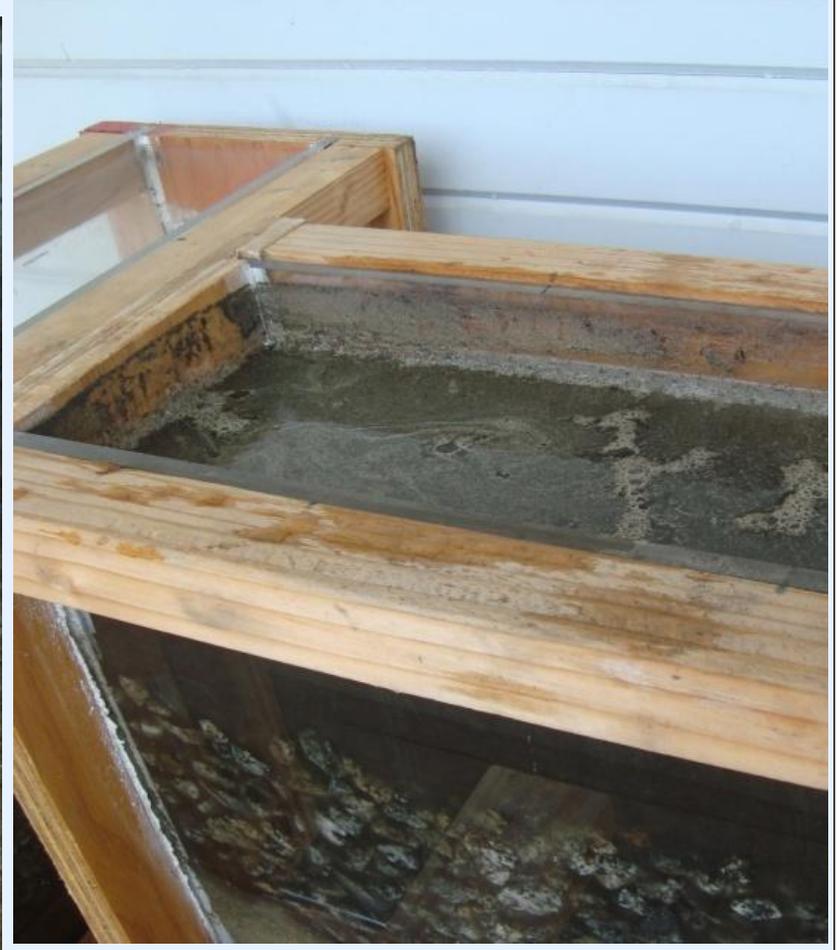
Clogging Mechanisms

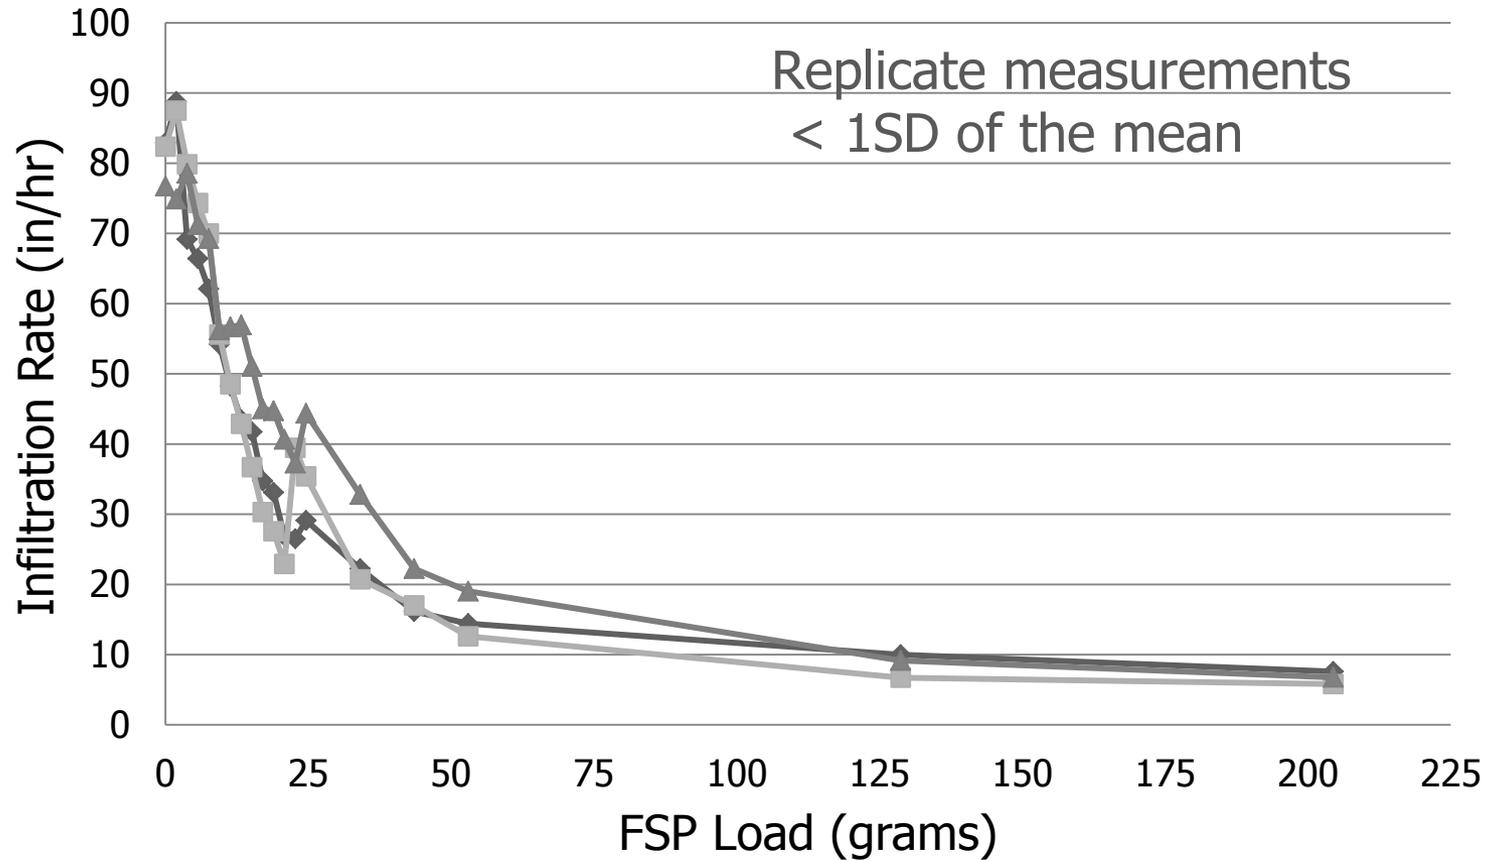
Infiltration Performance Decline

- All surface types not equal in clogging potential
- Results may indicate severe performance declines within 3 years
- Severe declines also results in loss of stormwater volume reduction benefits

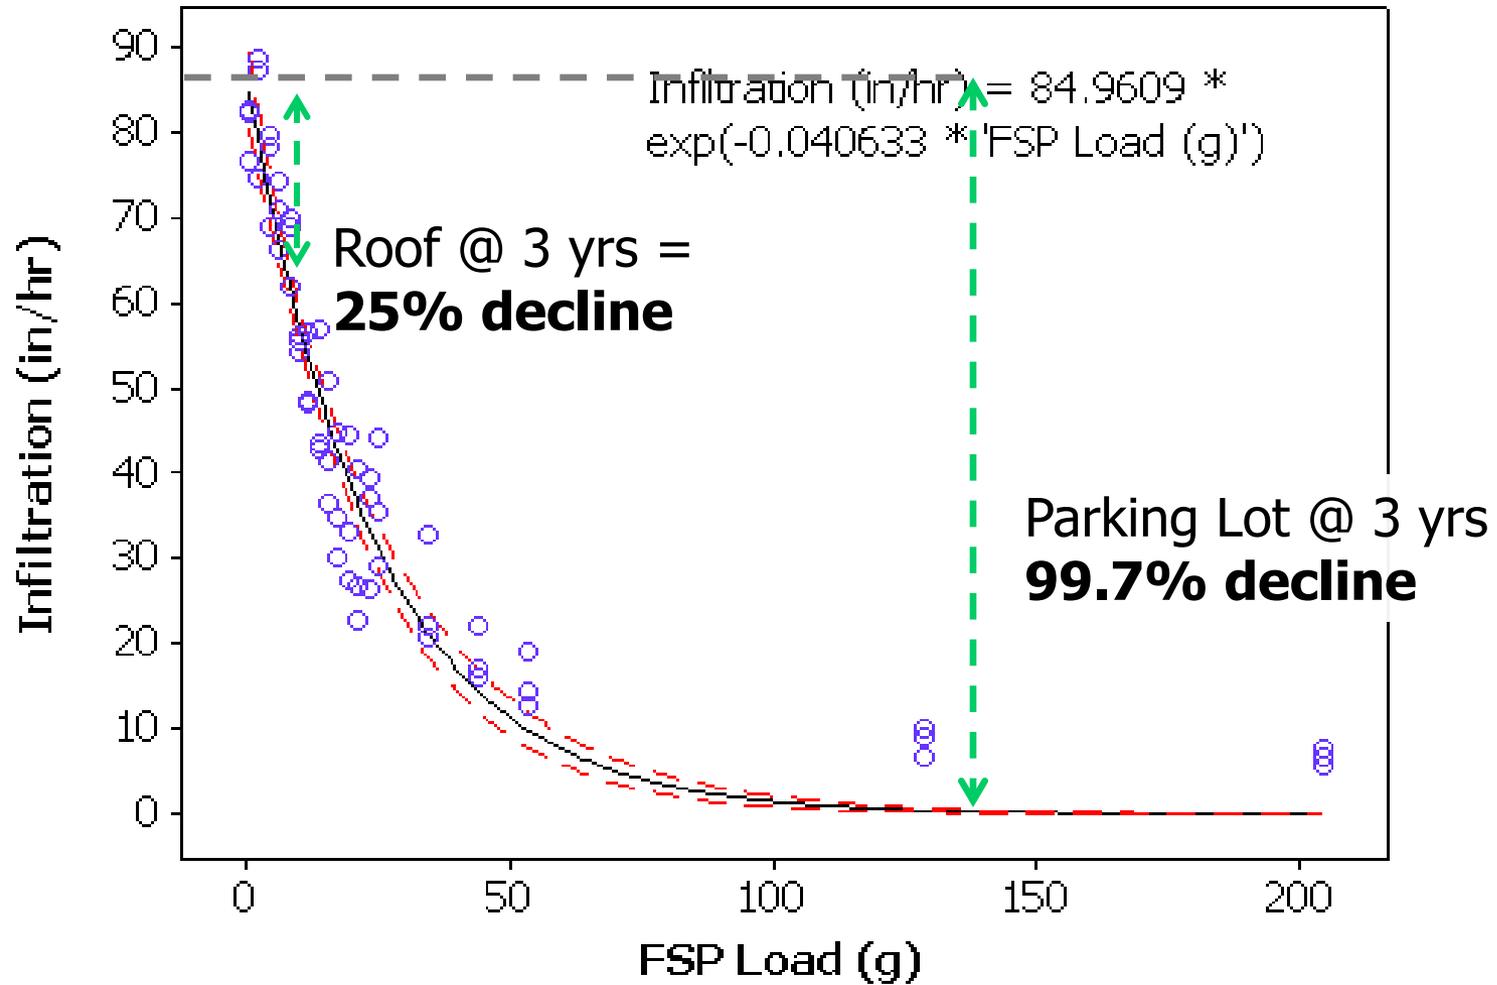
Scaling up to In-Situ BMPs

- Stormwater with constant FSP concentrations
- Rain = 30 in/yr, RO coef = 1
- BMP = No depth, 12.8 in/hr soil

Surface Type	BMP/ Drainage	FSP (mg/L)	3 year Infiltration Decline (%)
Roof	1:9	5	
Parking Lot	1:9	100
