Effectiveness of Aquatic Invasive Plant Control In Emerald Bay, Lake Tahoe

Dan Shaw – CA State Parks

Zach Hymanson – CA Tahoe Conservancy

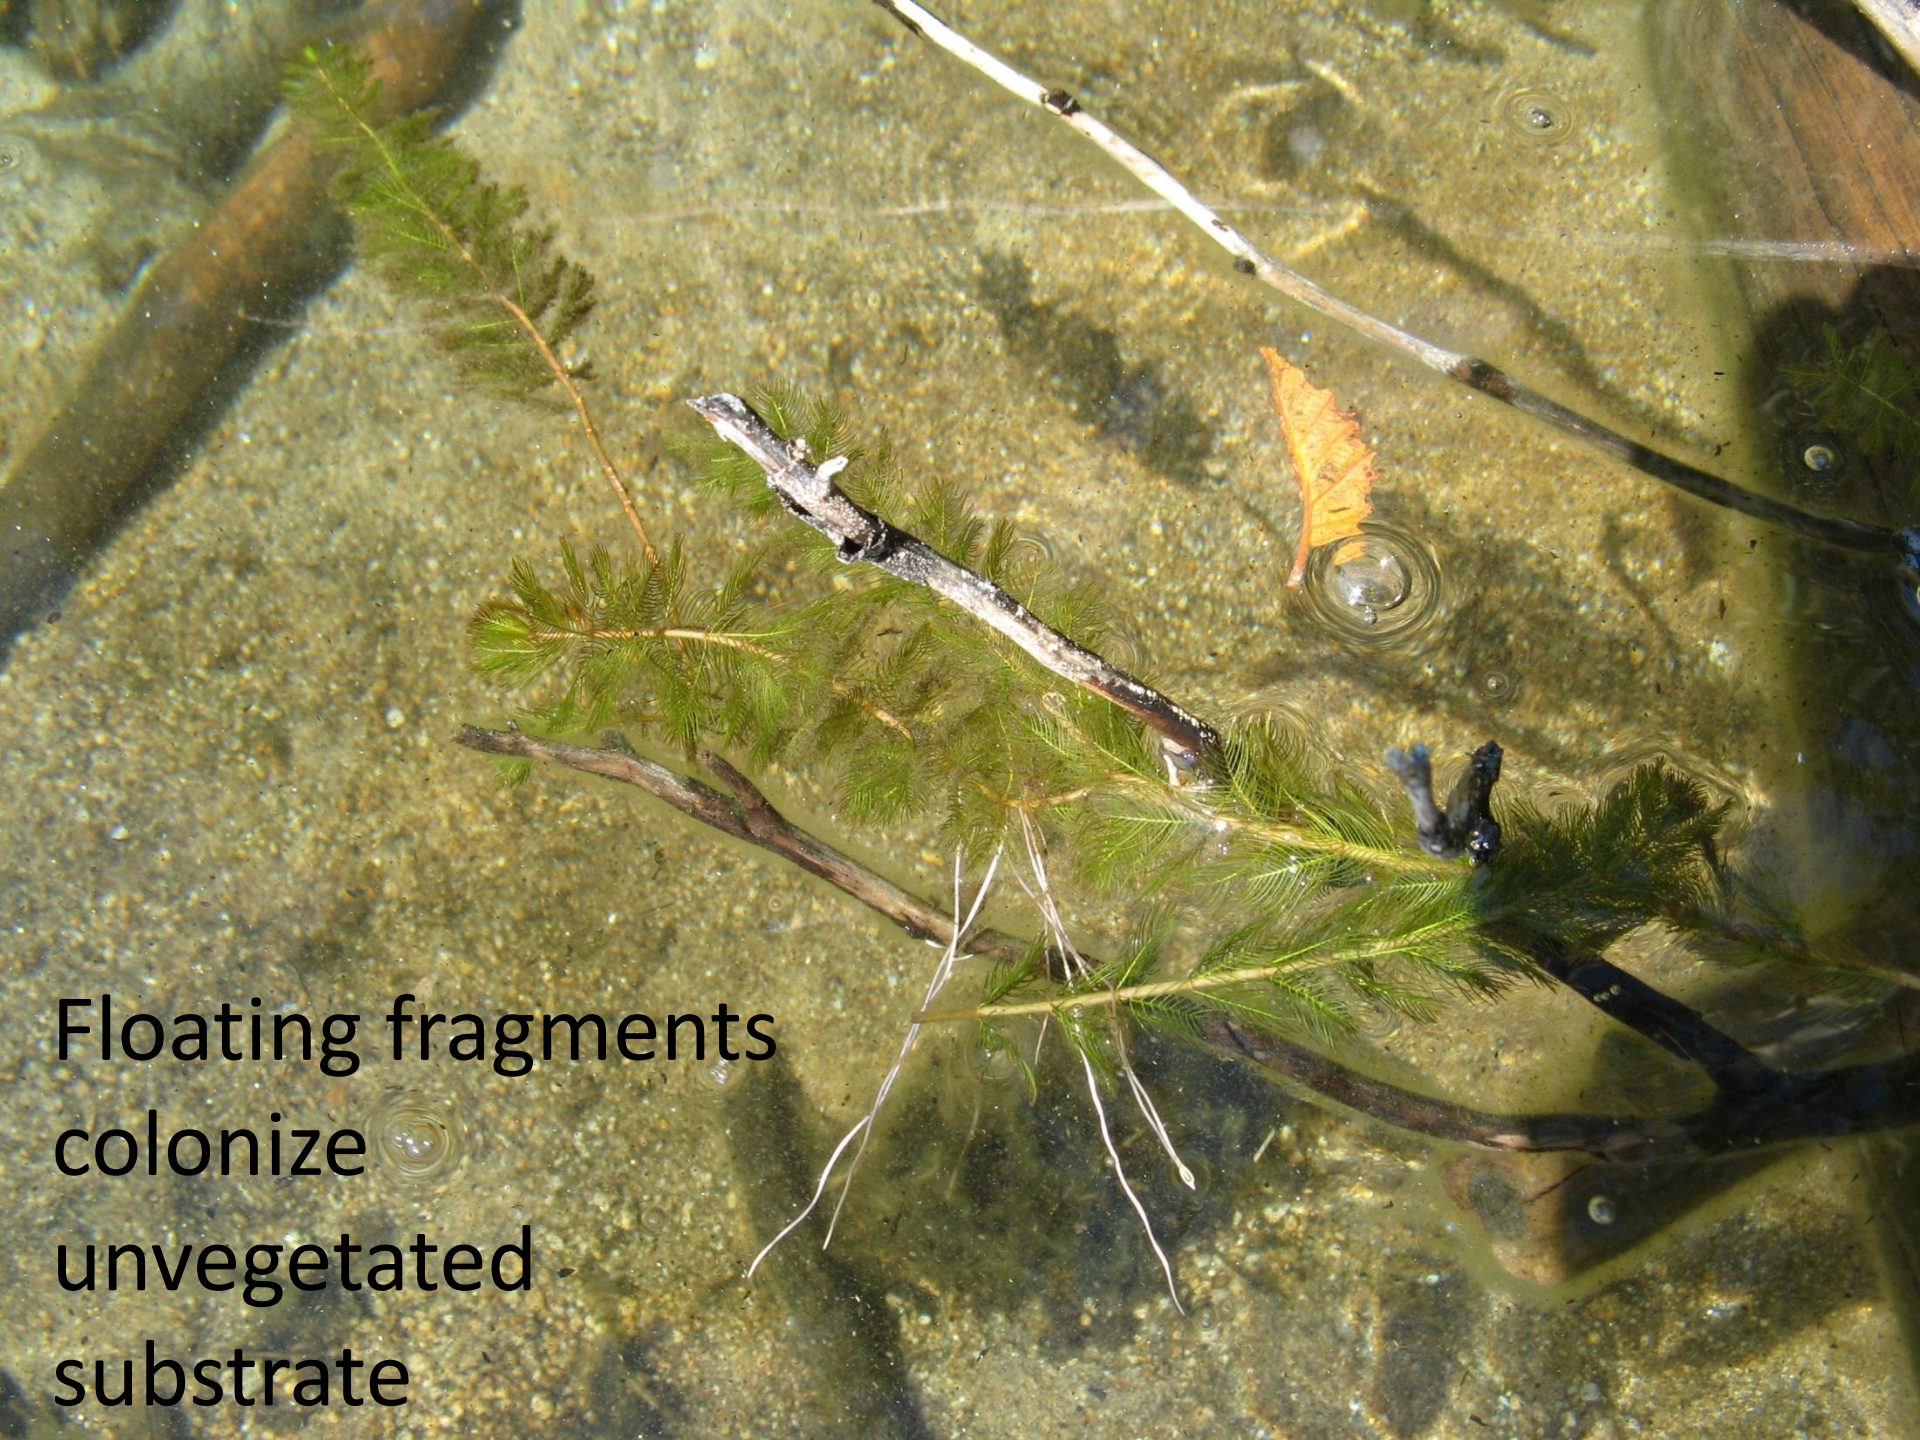
Floating fragments
colonize
unvegetated
substrate

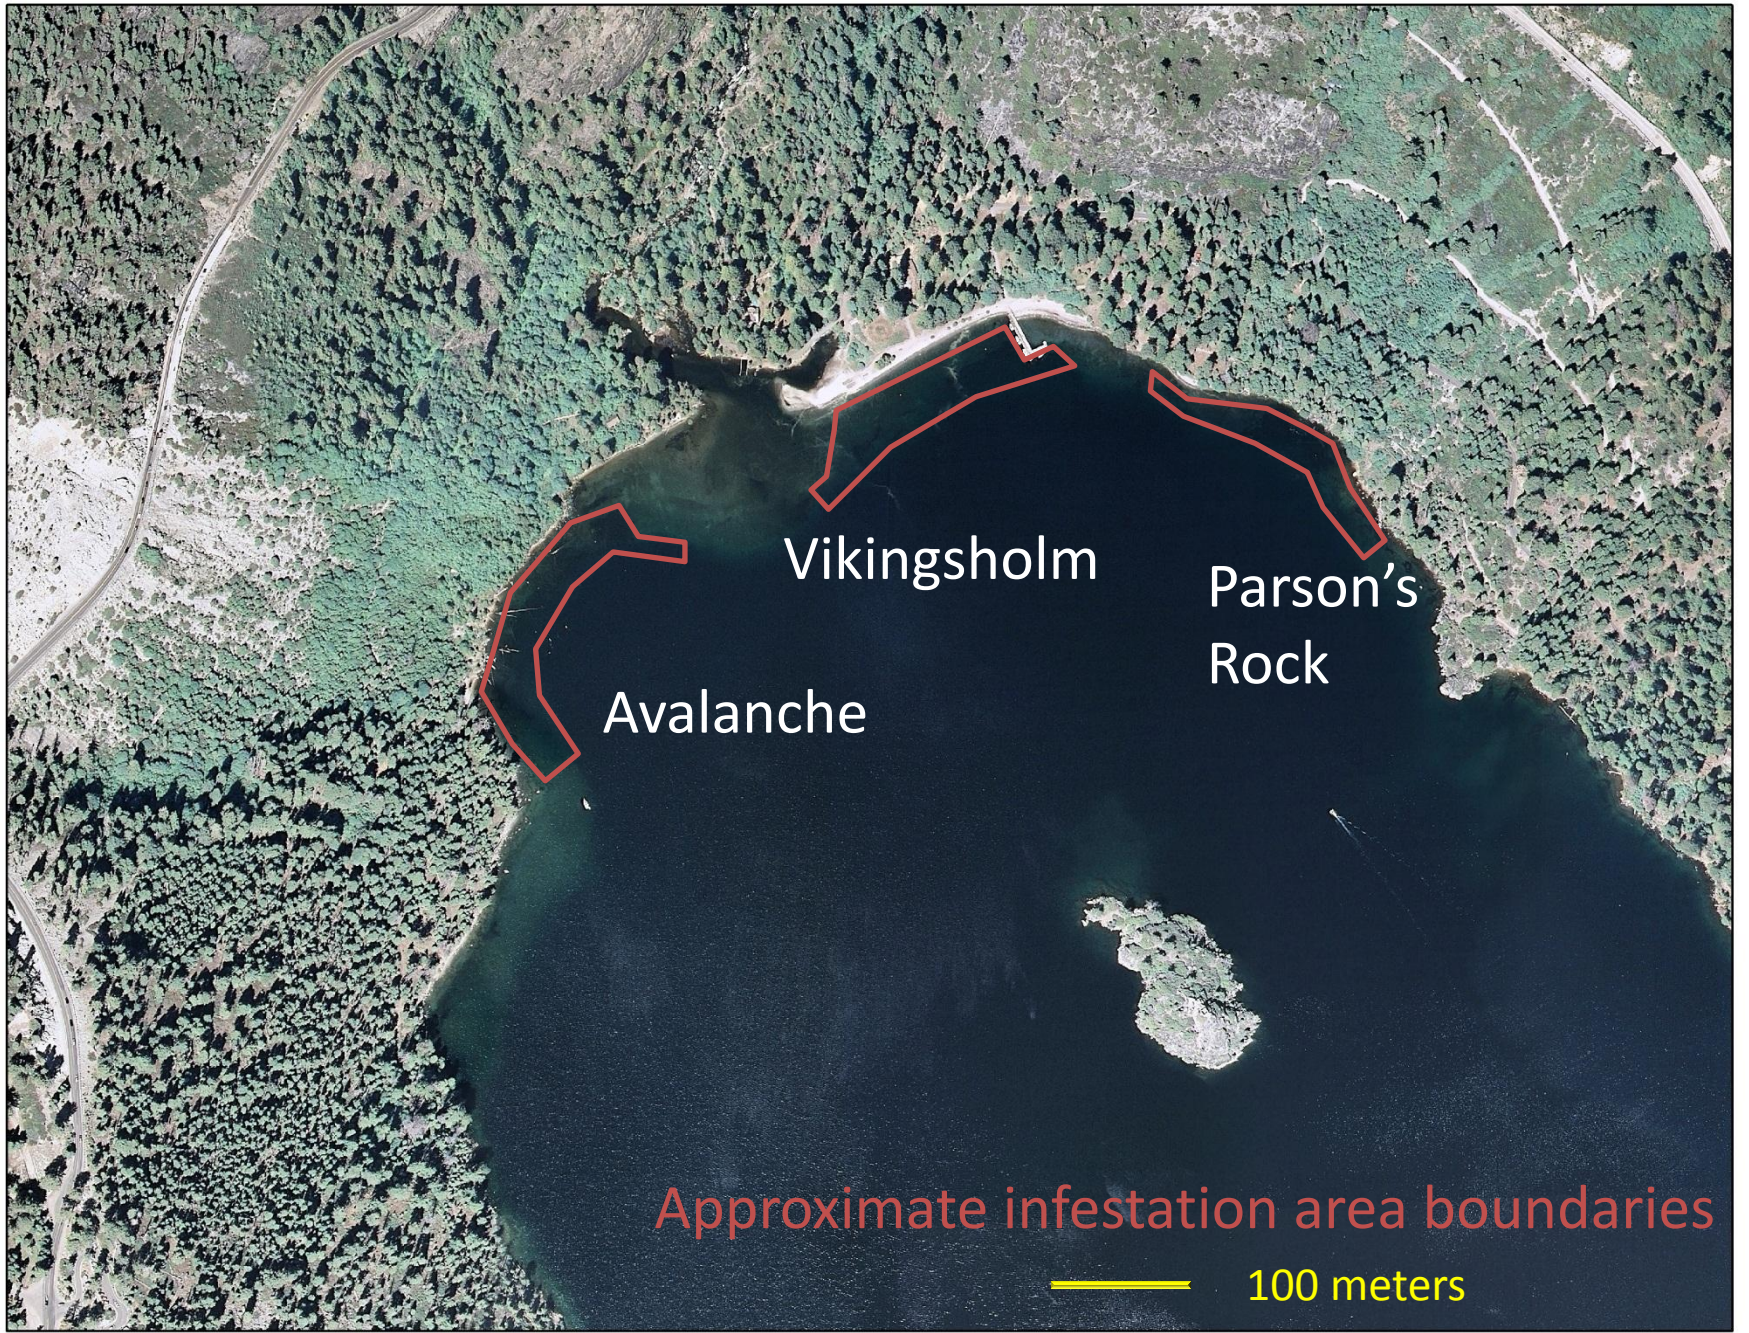
Project Area

Vikingsholm

Parson's
Rock

Avalanche

Approximate infestation area boundaries

100 meters

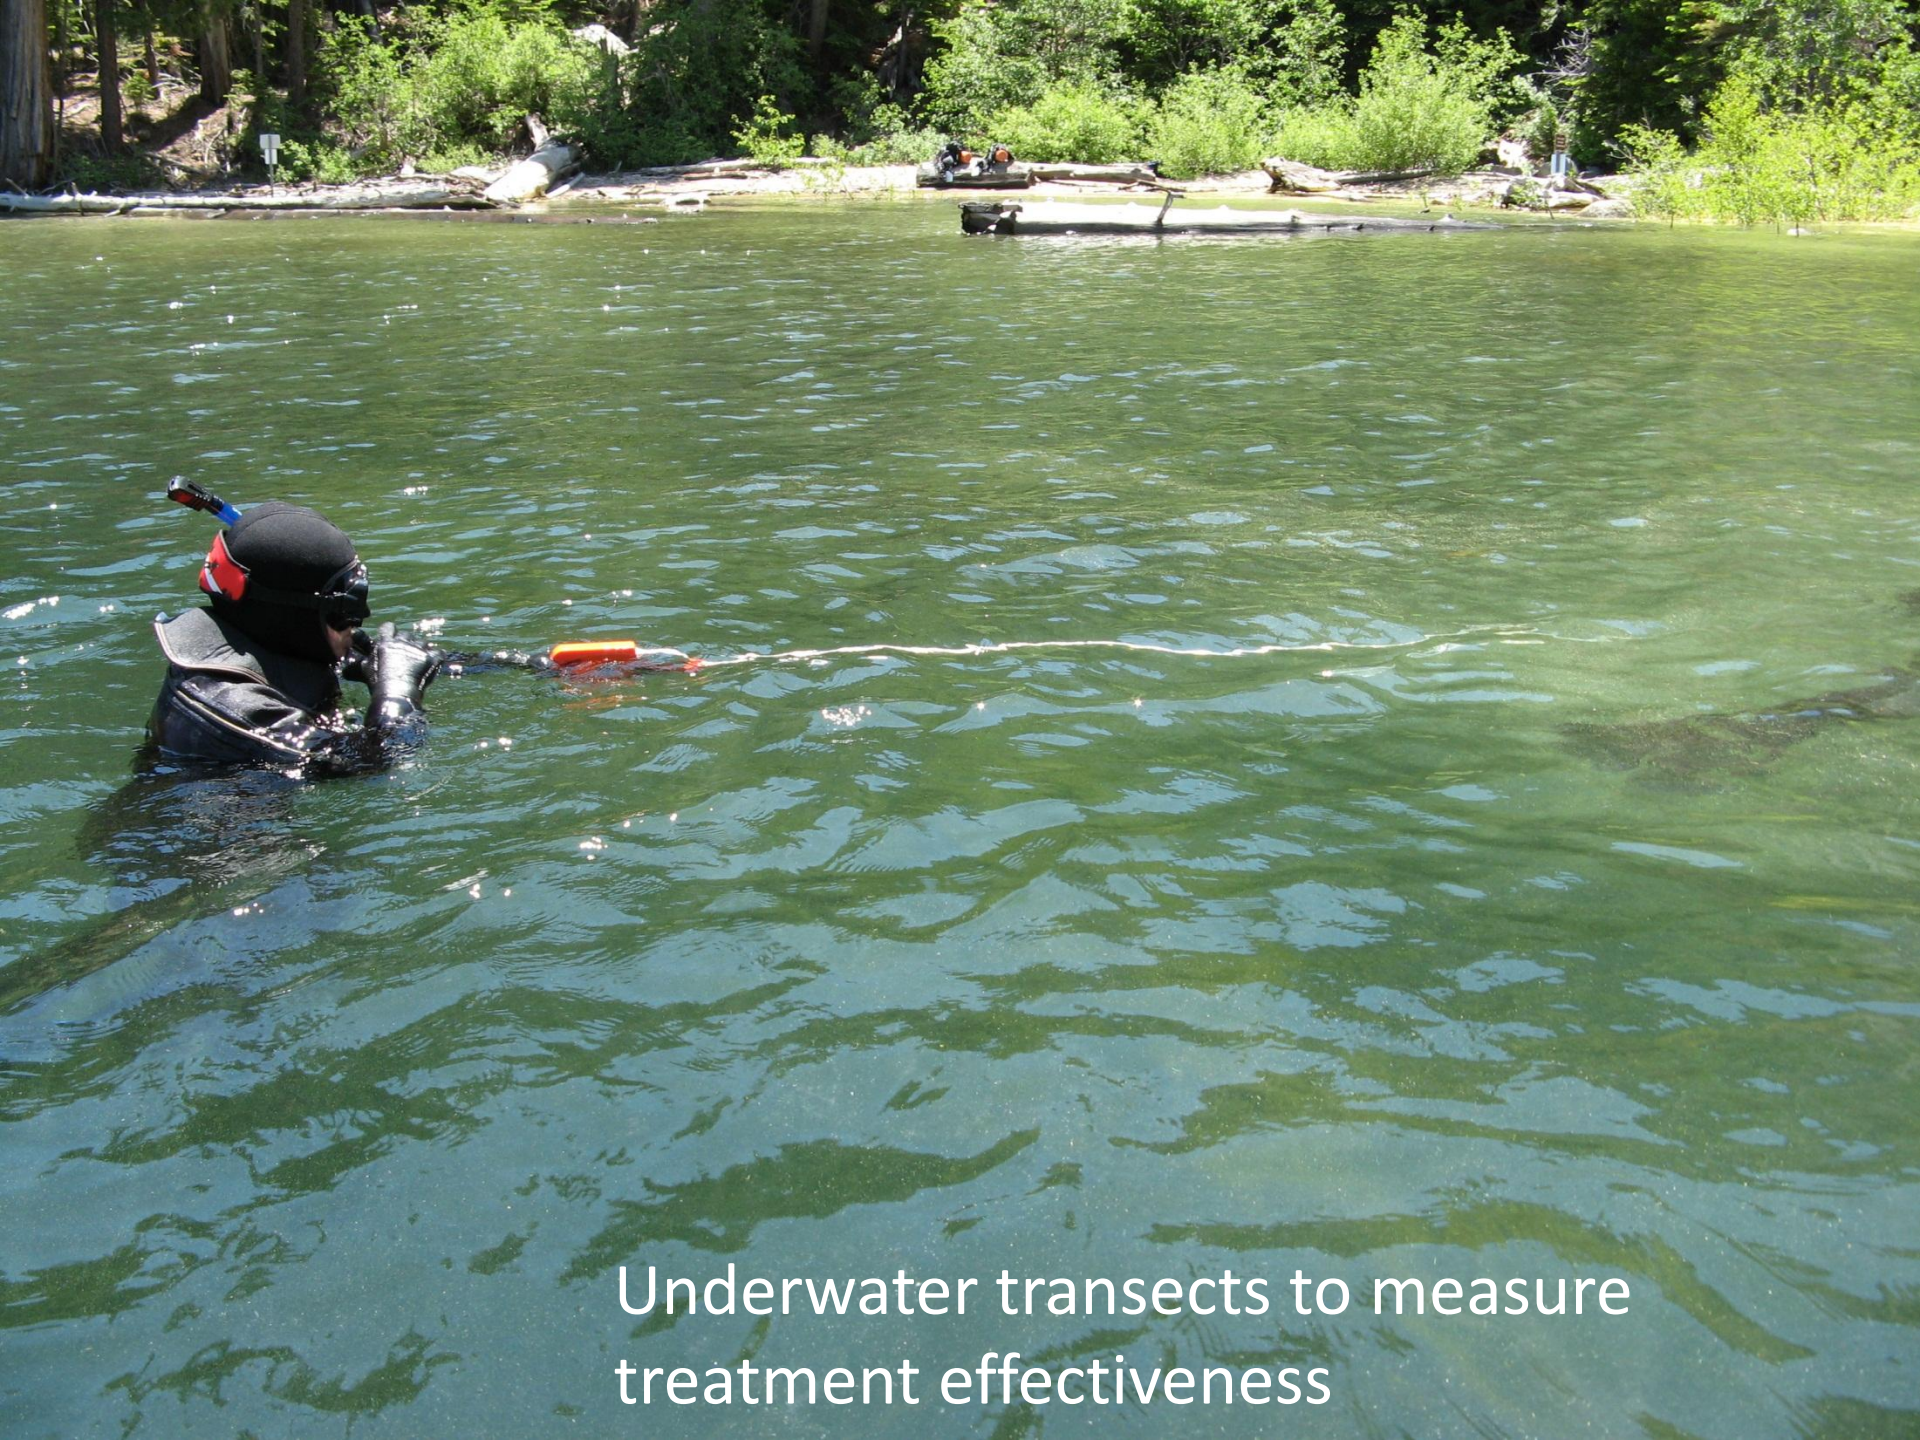
Underwater transects to measure
treatment effectiveness

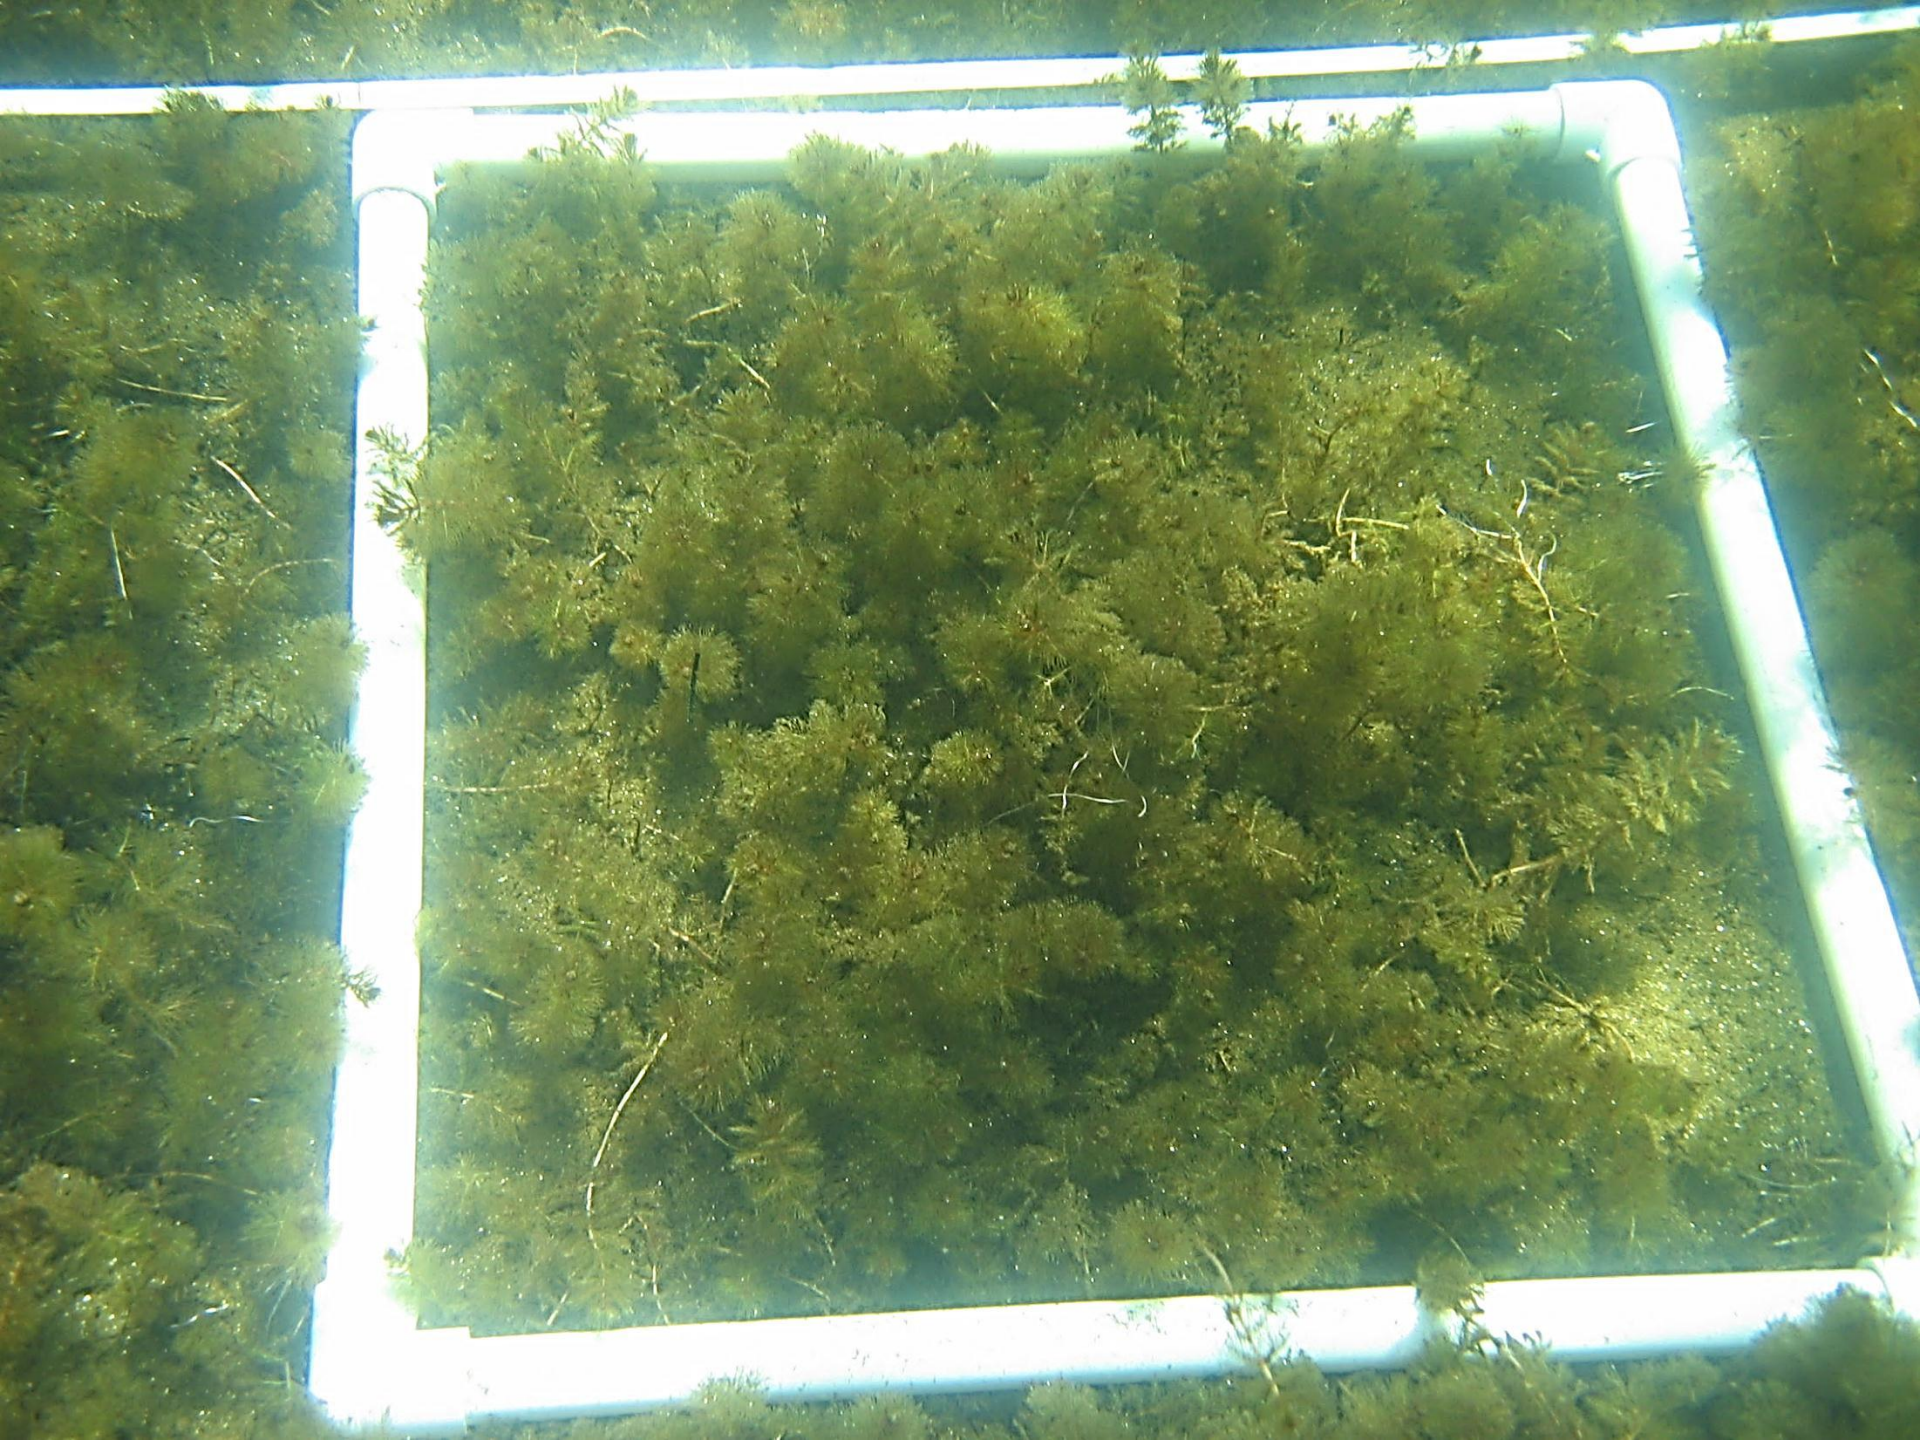
Benthic Barriers

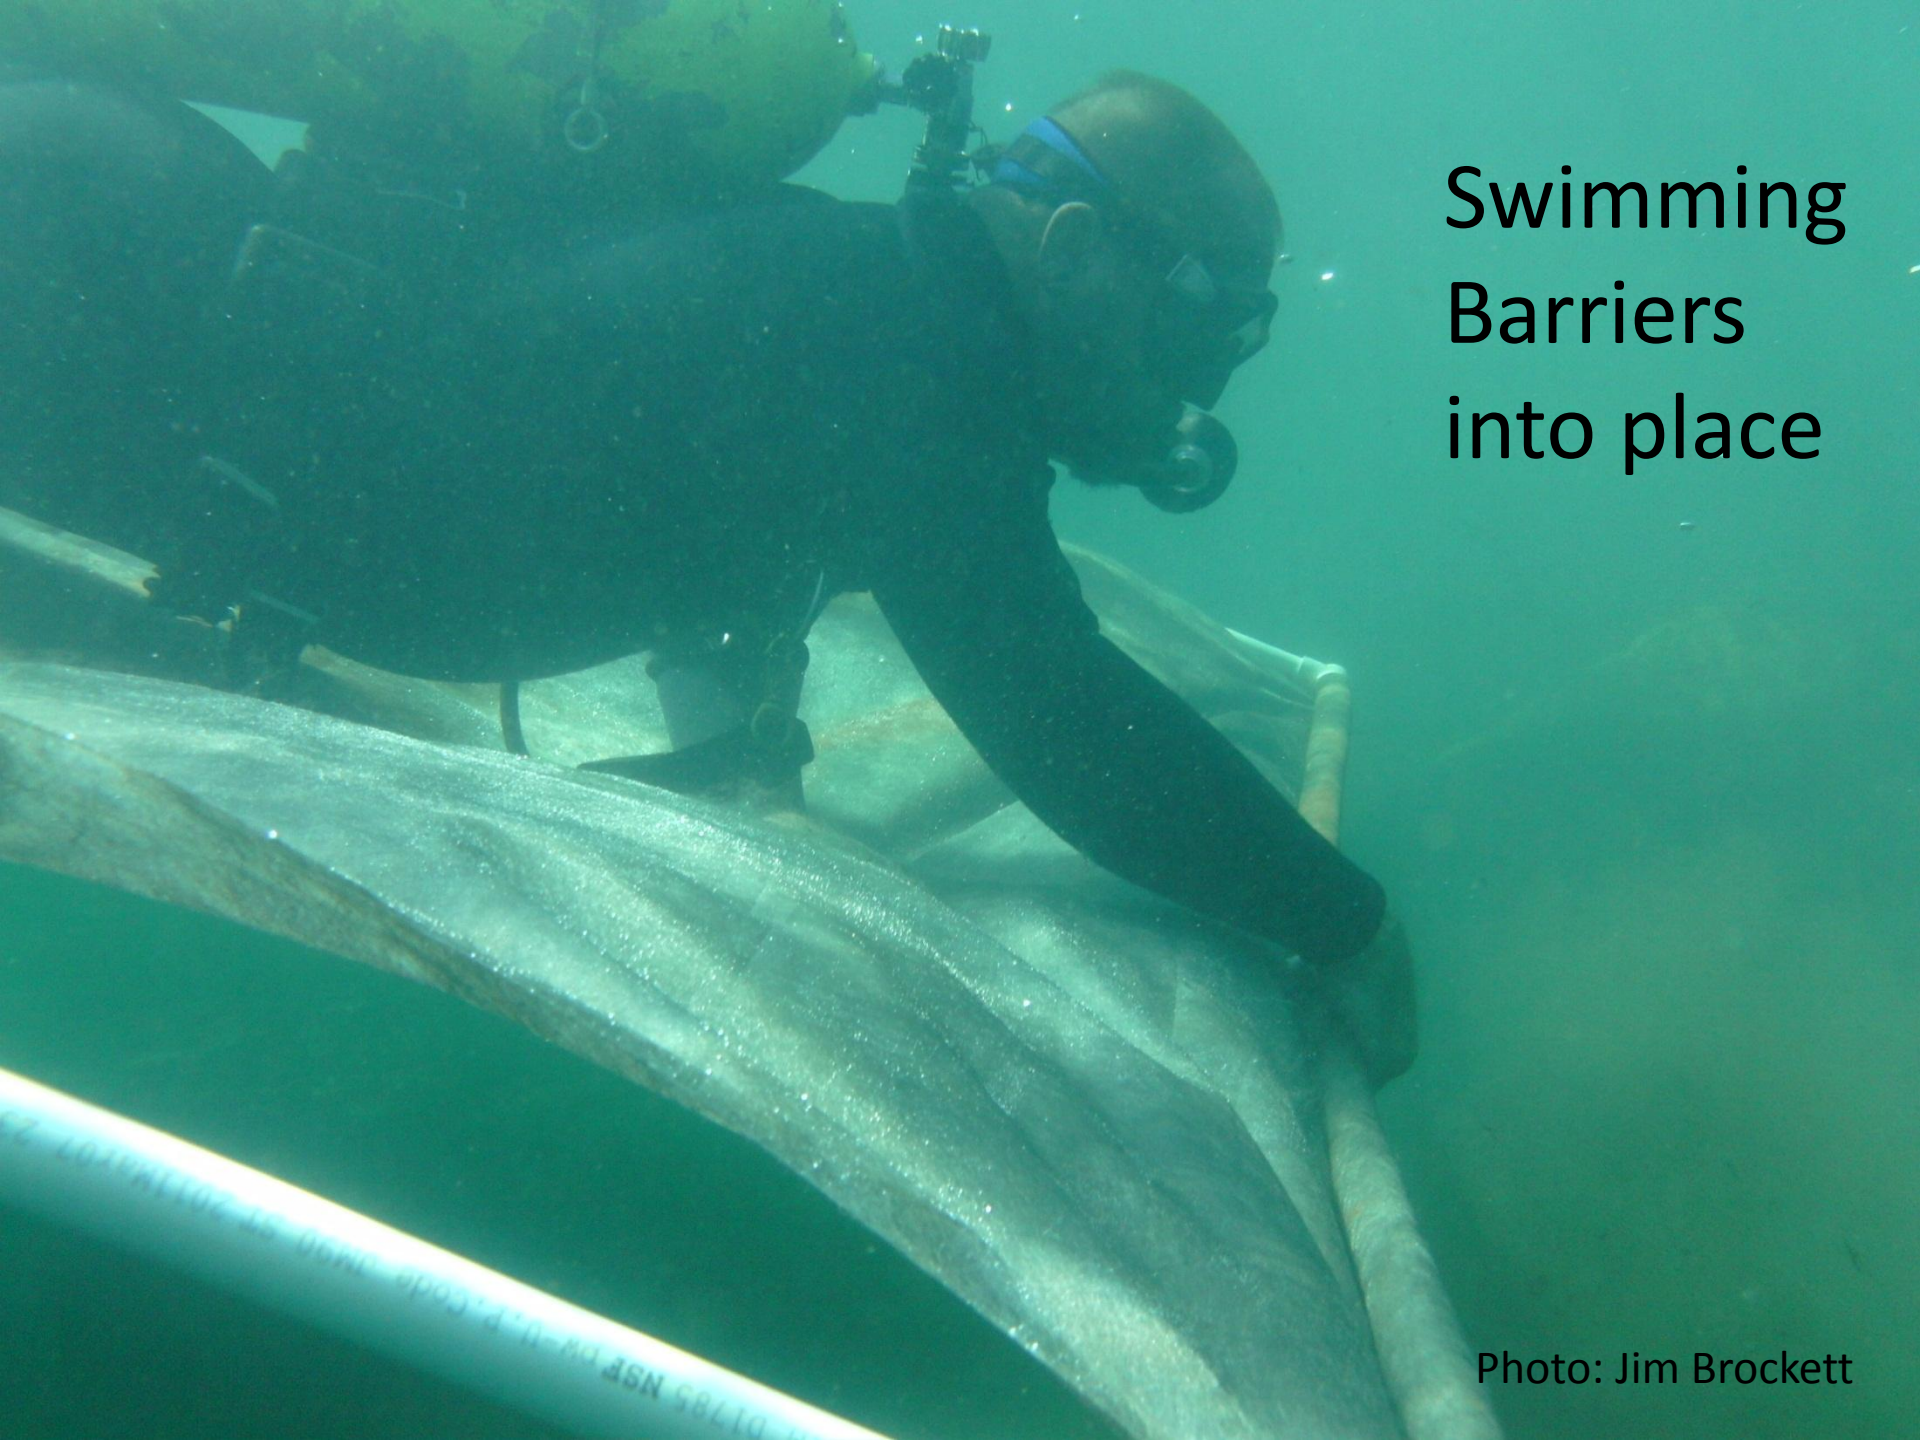
Swimming
Barriers
into place

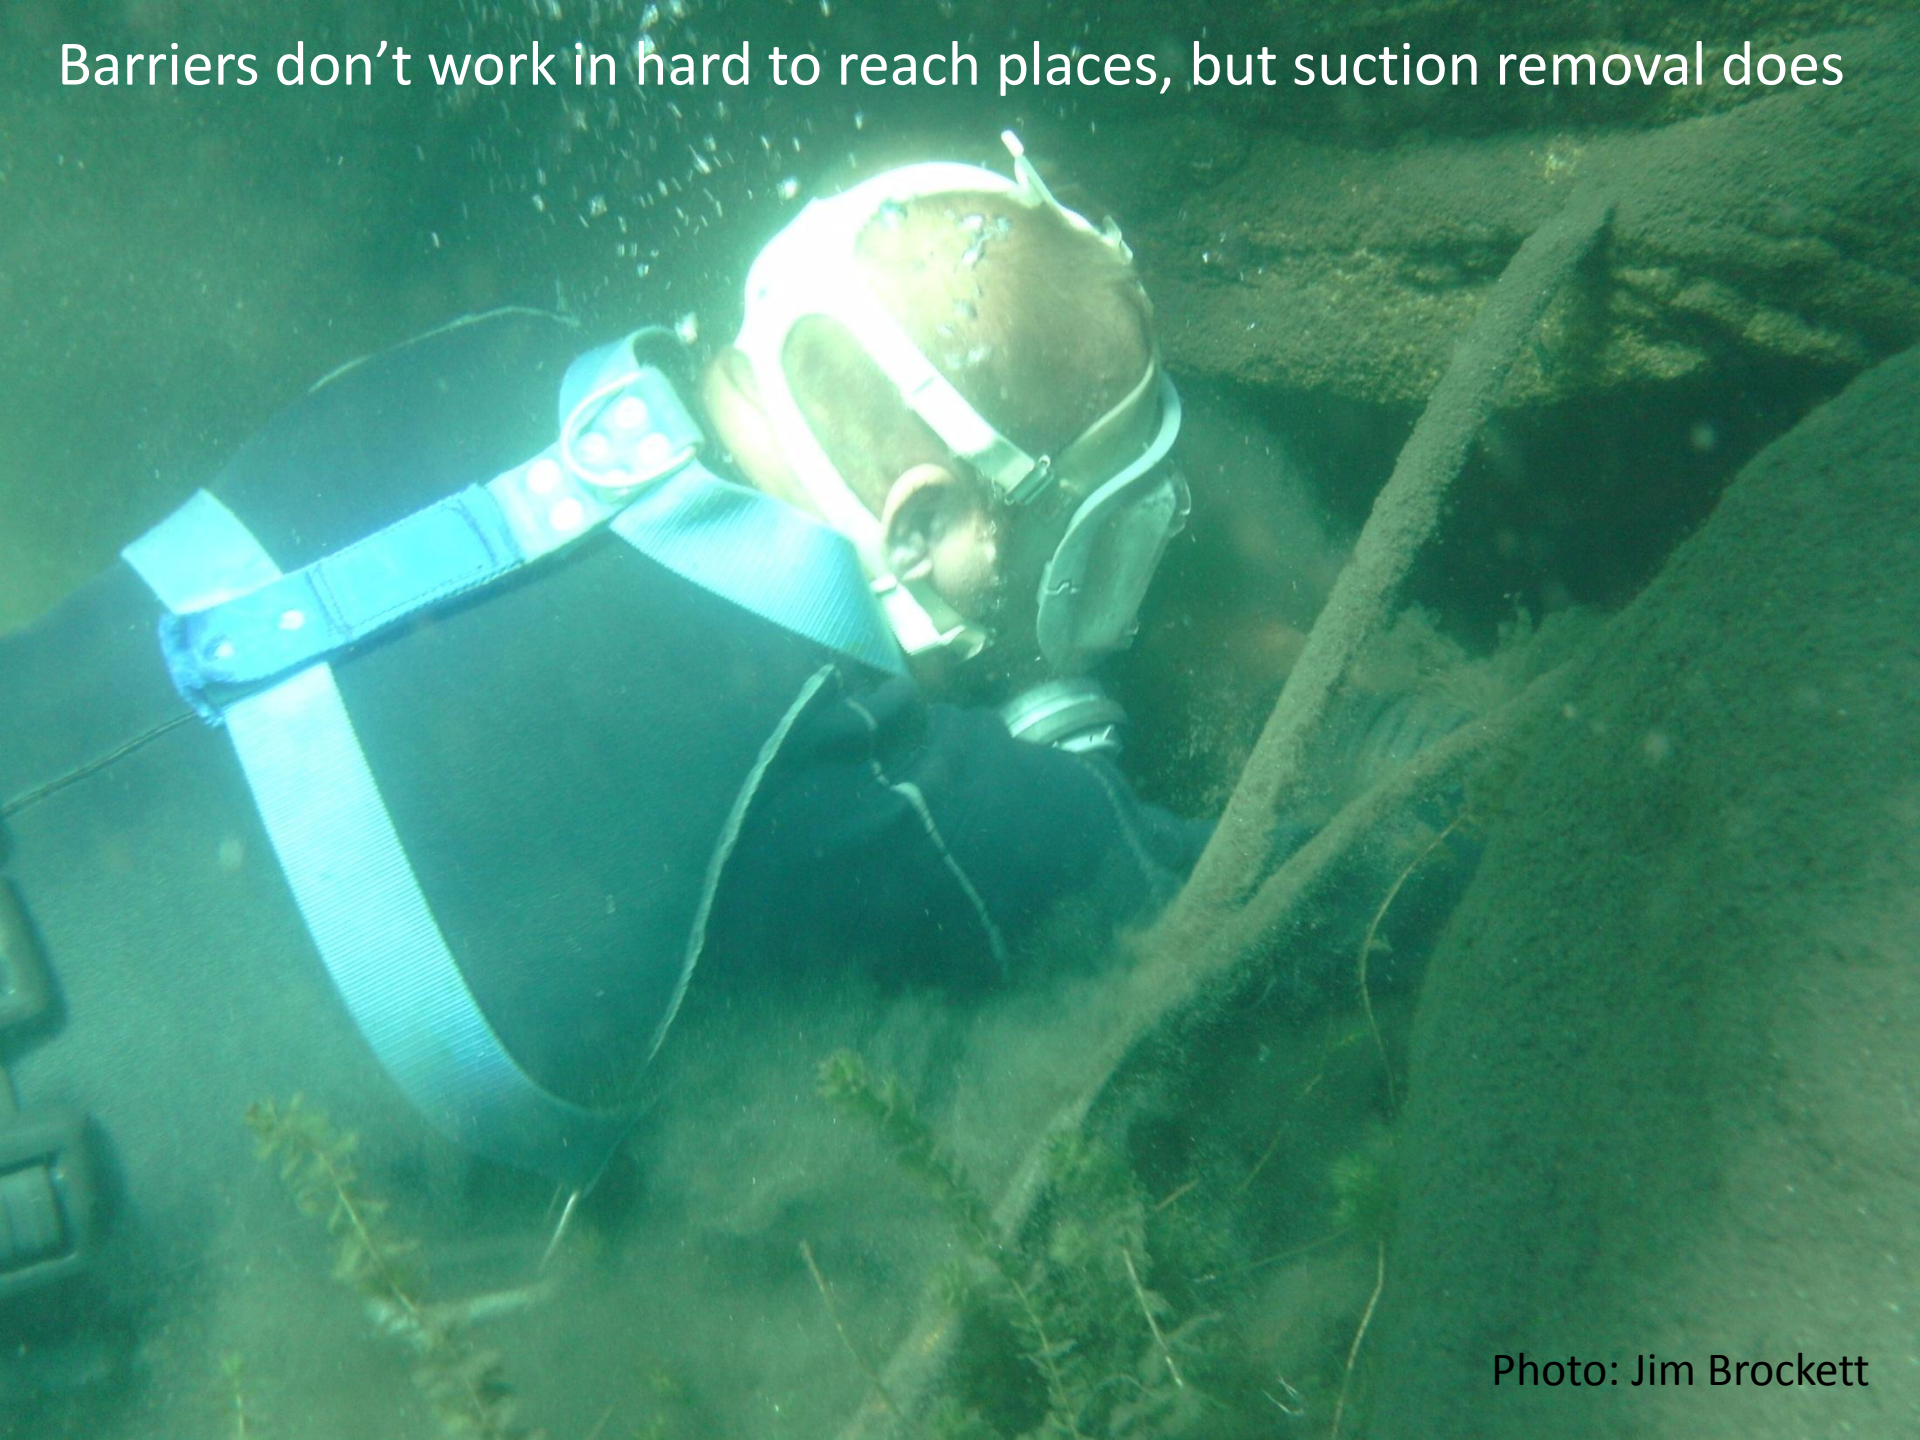
Barriers don't work in hard to reach places, but suction removal does

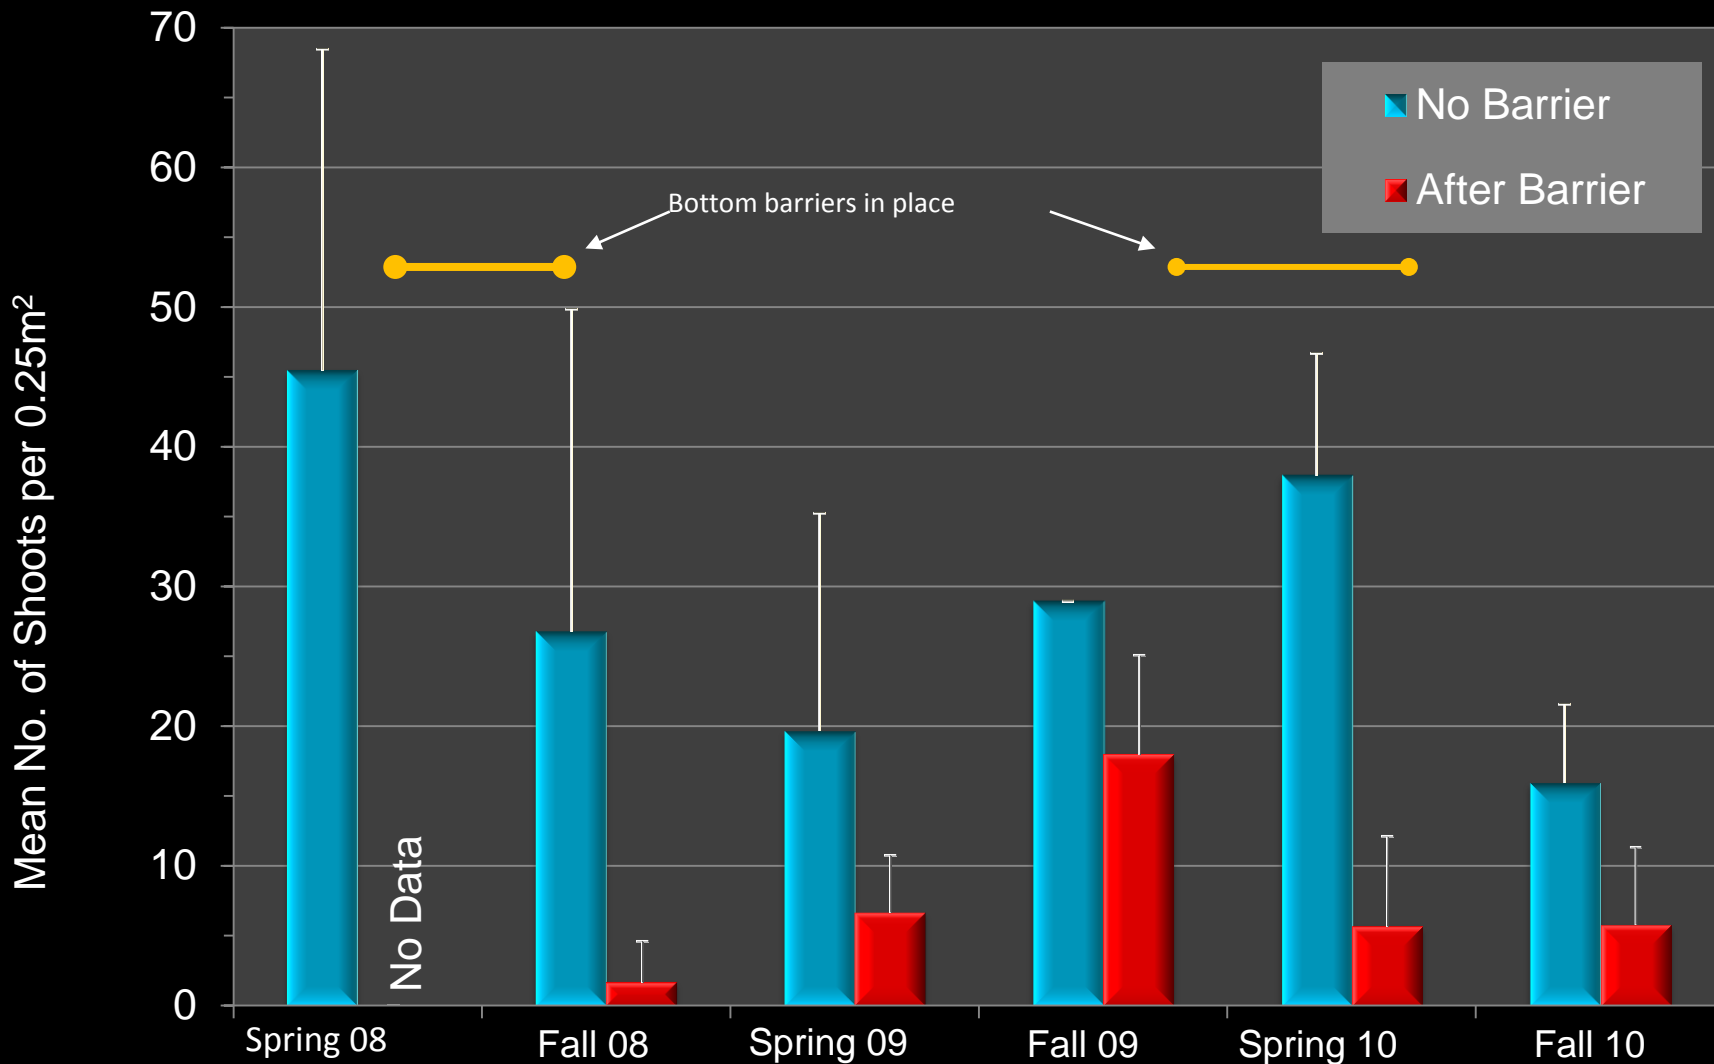
EWM Densities at Parsons Rock Site

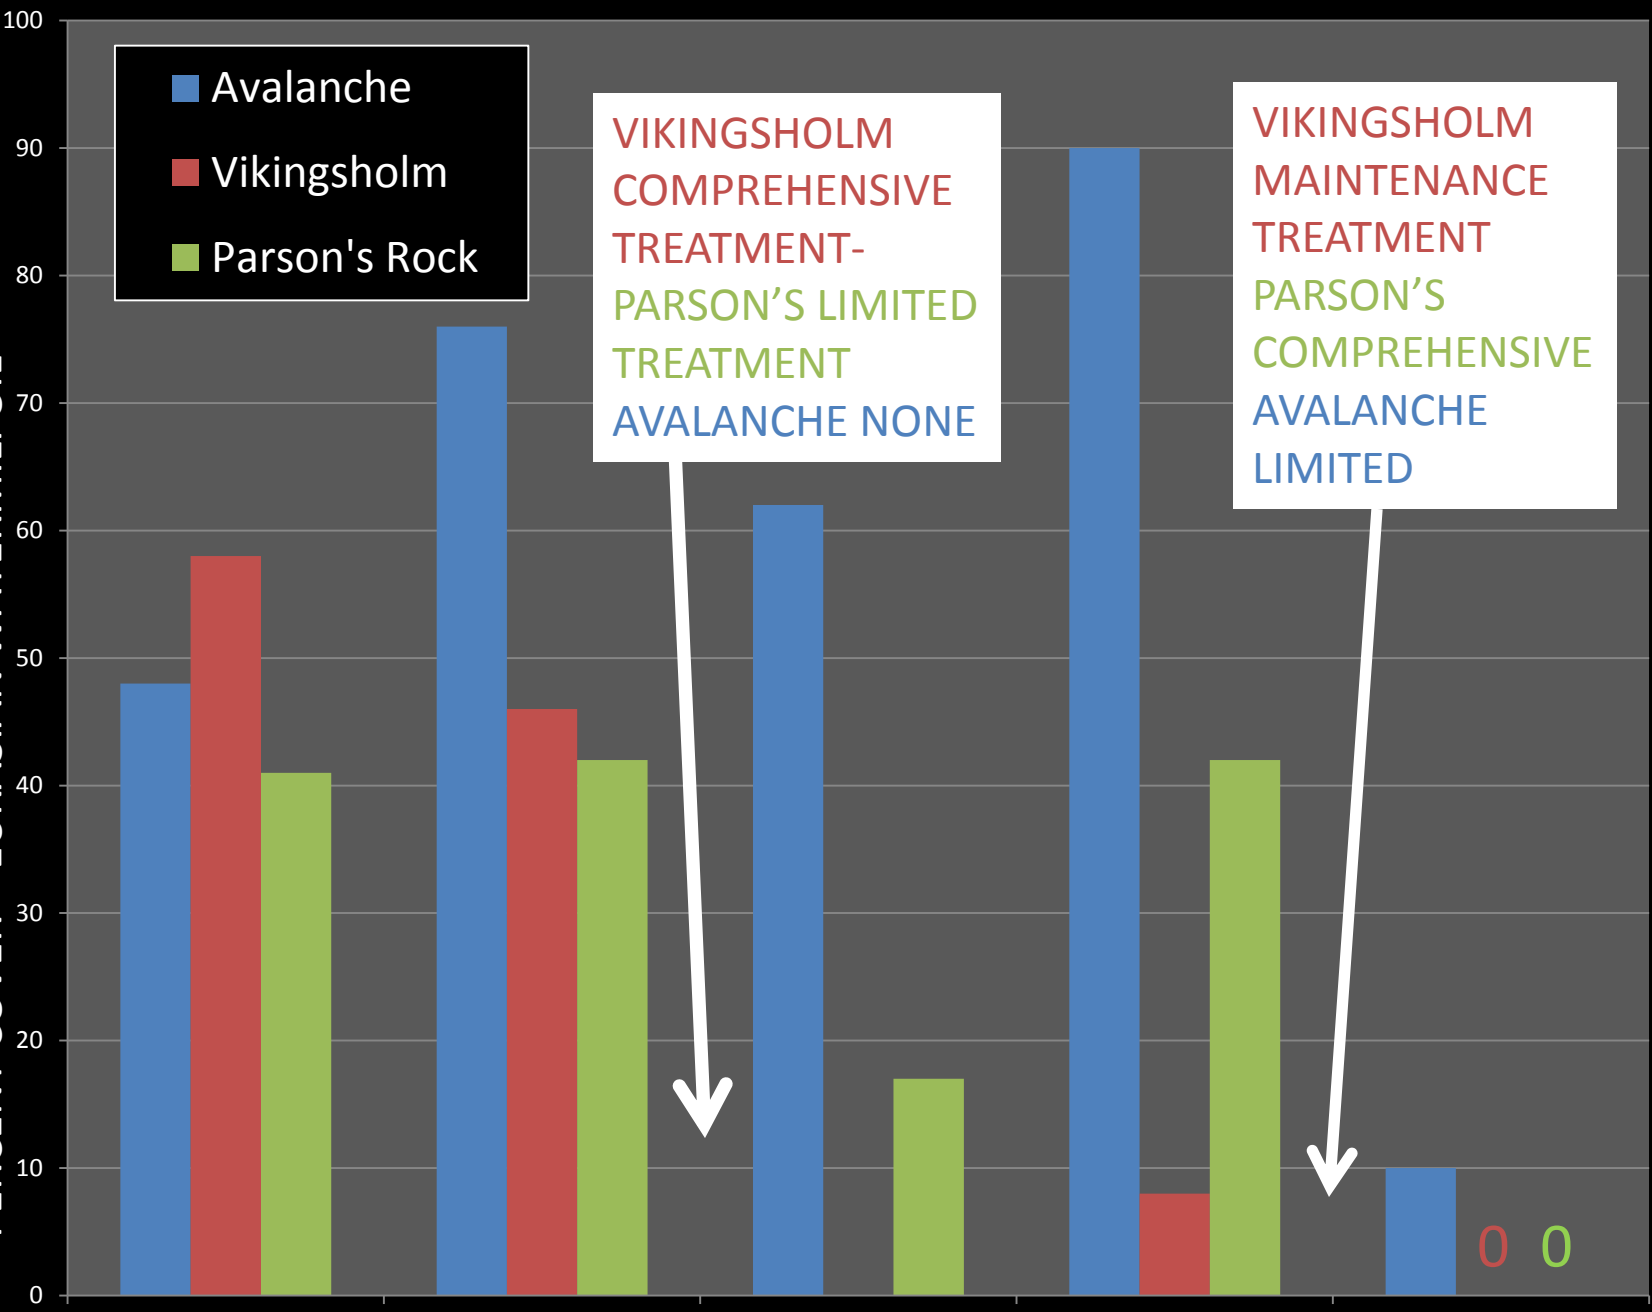
PERCENT COVER – EURASIAN WATERMILFOIL

VIKINGSHOLM
COMPREHENSIVE
TREATMENT-
PARSON'S LIMITED
TREATMENT
AVALANCHE NONE

VIKINGSHOLM
MAINTENANCE
TREATMENT
PARSON'S
COMPREHENSIVE
AVALANCHE
LIMITED
