# Phase IIIA- Completion of restoration actions, 2009

## Blackwood Phase I and II

## Blackwood Phase IIIA – Reach 6

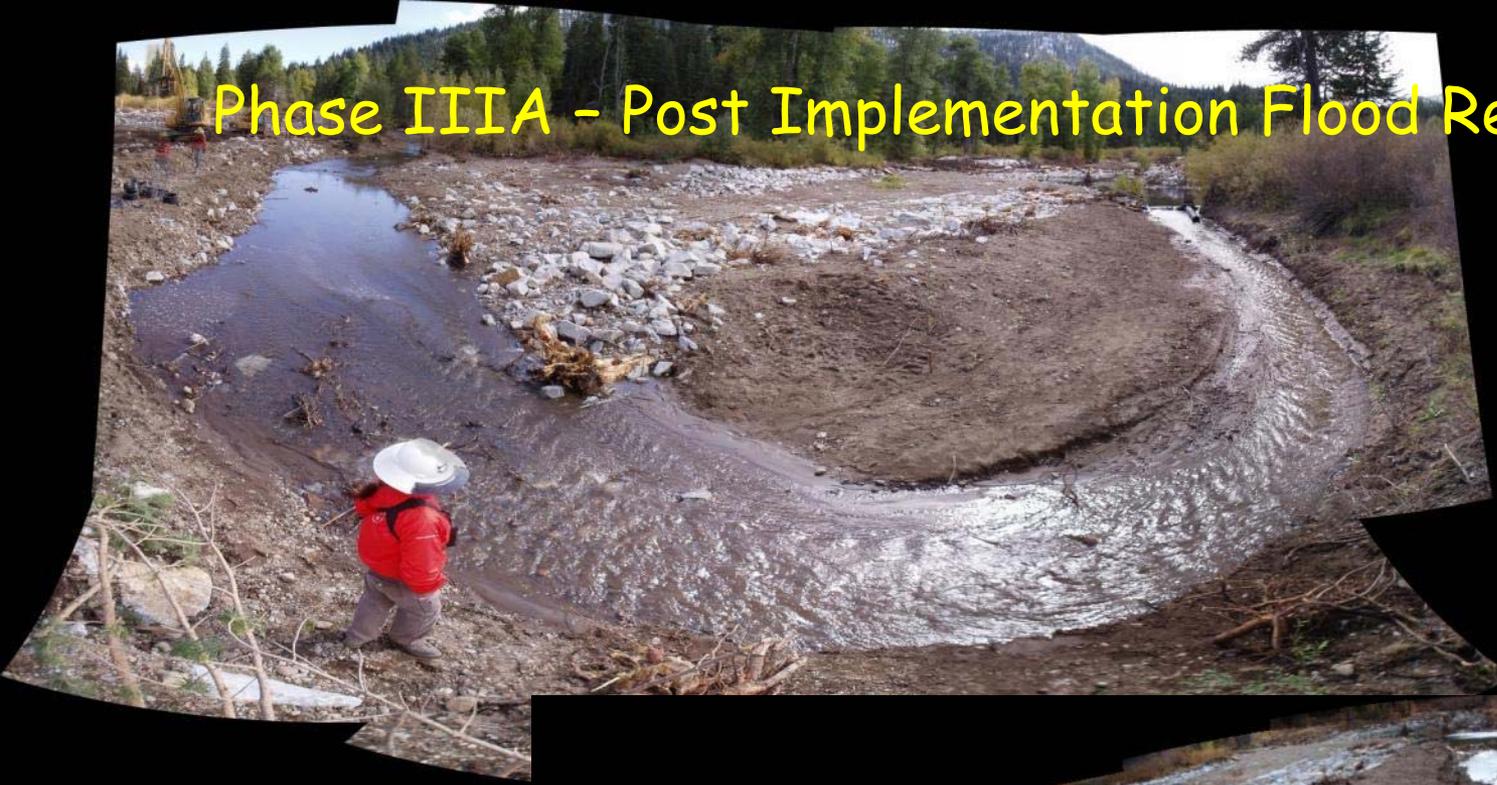
10-12-09

# Phase IIIA - Post Implementation Flood Response

~7" precip @ Ward  
snotel on 10/14  
USGS real time @  
Blackwood  
20 to 100 cfs in 30  
min.
