# Blackwood Creek Stream and Floodplain Restoration; a Novel Approach in a Dynamic and Changing Environment

US Forest Service, Lake Tahoe Basin Management Unit

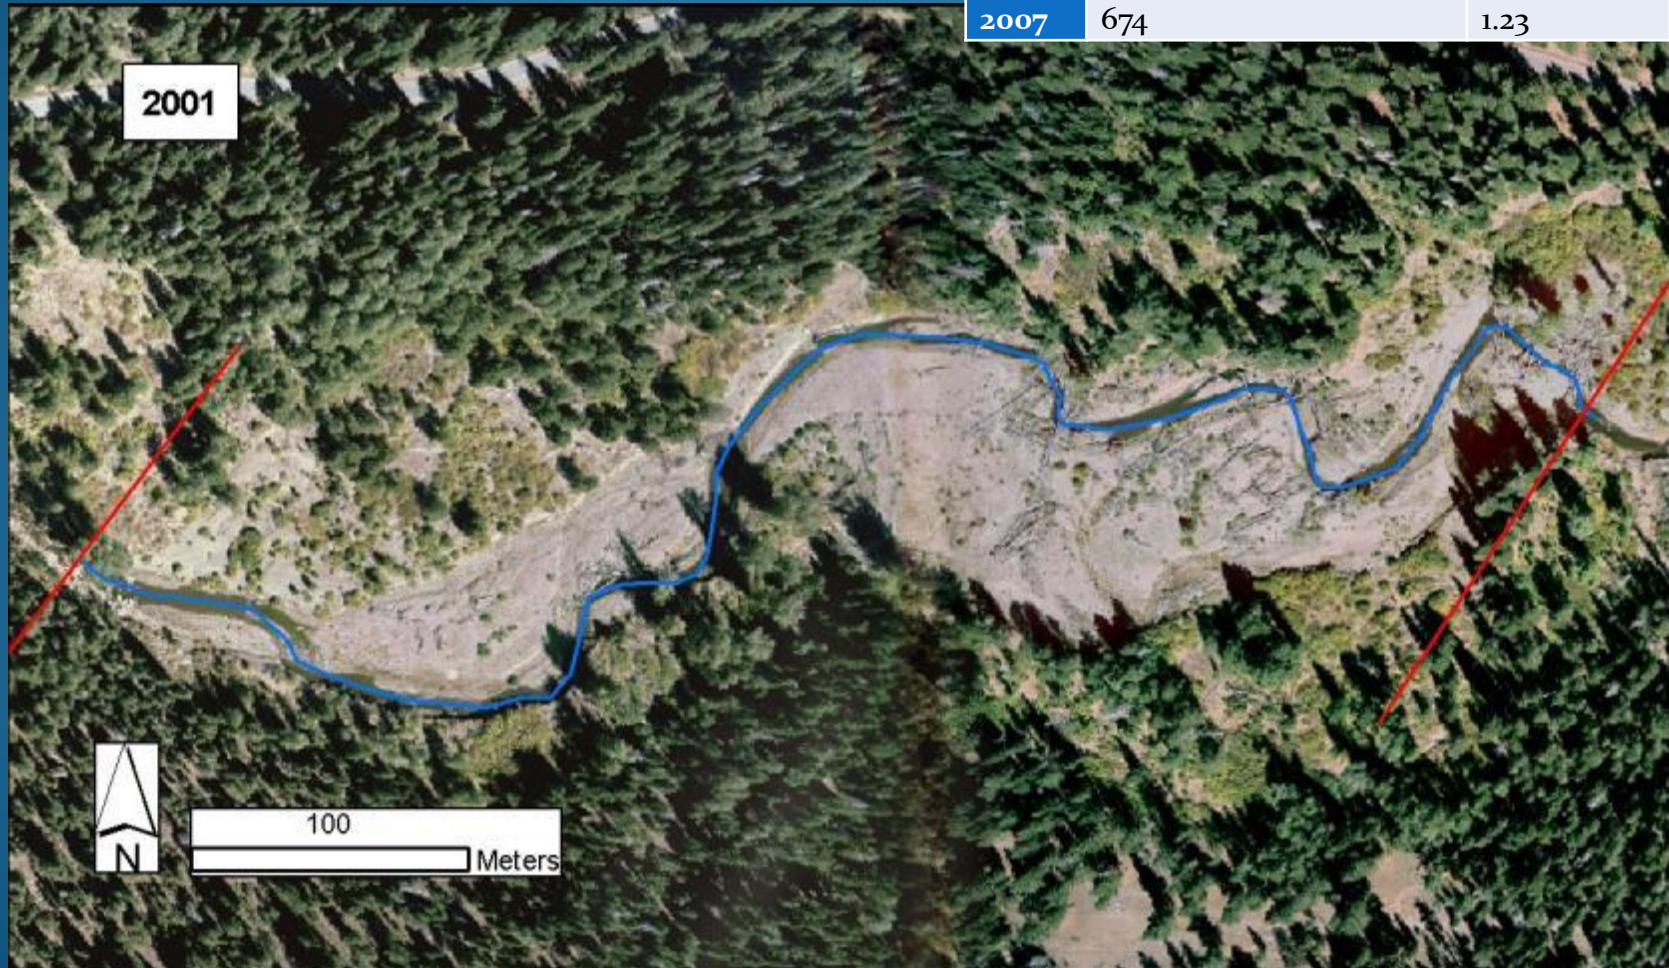
# 2001 Reach 6 Aerial Photo

Year	Channel Length (m)	Sinuosity
1939	985	1.80
1969	894	1.63
1986	835	1.53
1995	777	1.42
2001	731	1.34
2007	674	1.23

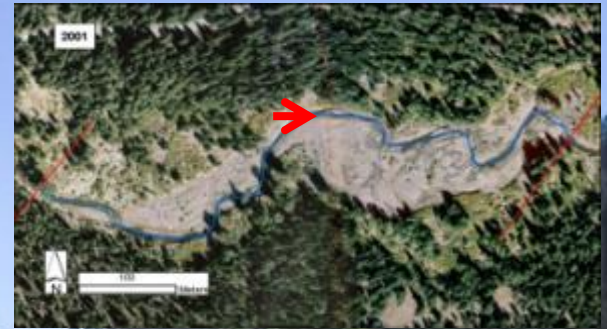
“ highly unstable with  
little evidence of the  
floodplain recovering  
from previous erosion  
“ – Swanson 2003

Post 12/31/05 flood. Photo taken 7/2006

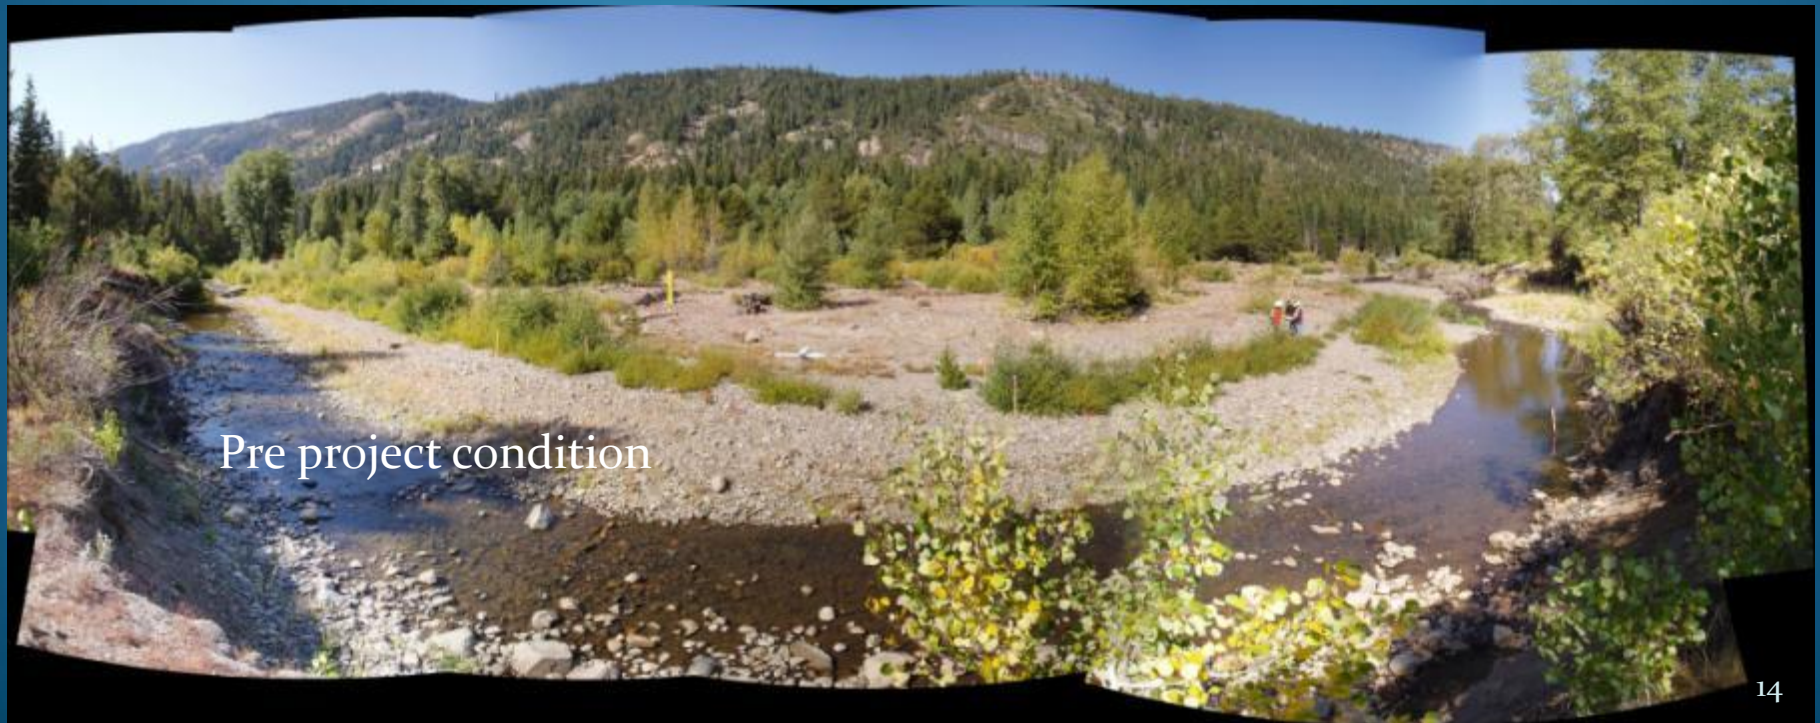
# Restoration Work in Reach 6

- Project constructed in 2008 and 2009
- Channel lengthened from 674 m to 1,090 m
- Design
  - New channel construction through Reach 6
  - Flow deflection structures of rock and logs
  - Incorporated floodplain depressions

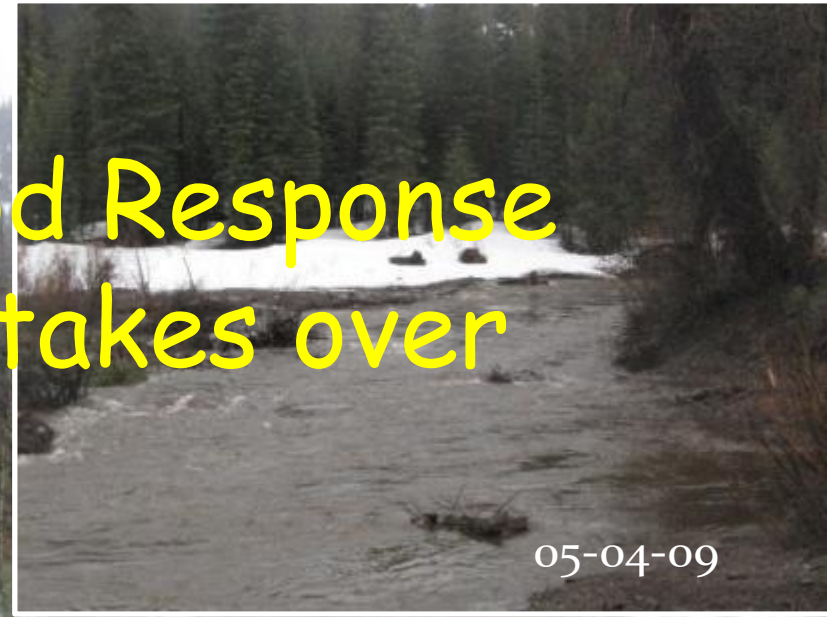
# Phase IIIA - Flood Response Blackwood Creek takes over

2009 peak flow = 590  
2010 peak flow = 440  
2011 peak = 650-700  
2012 peak = 500

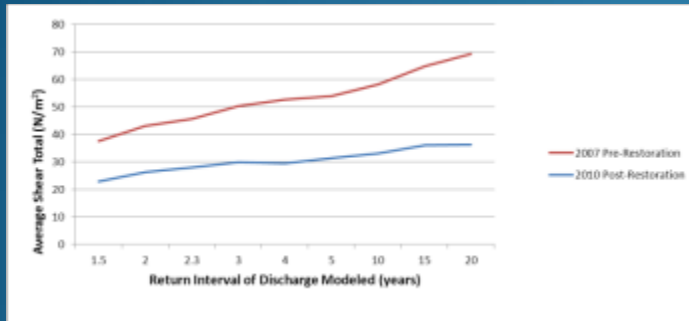
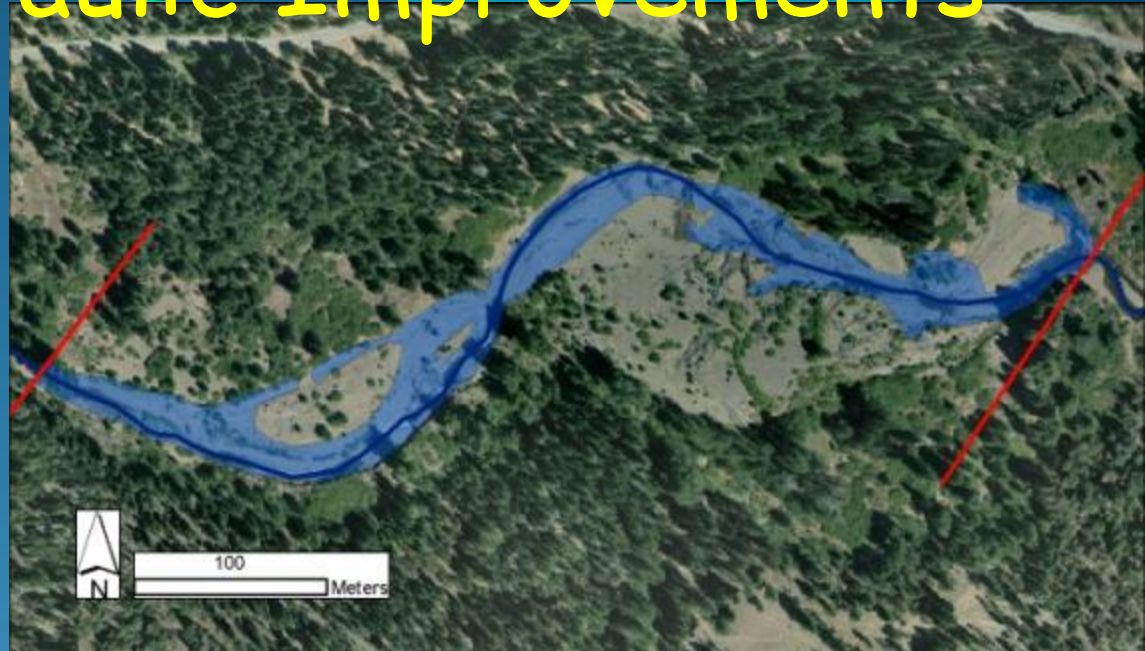
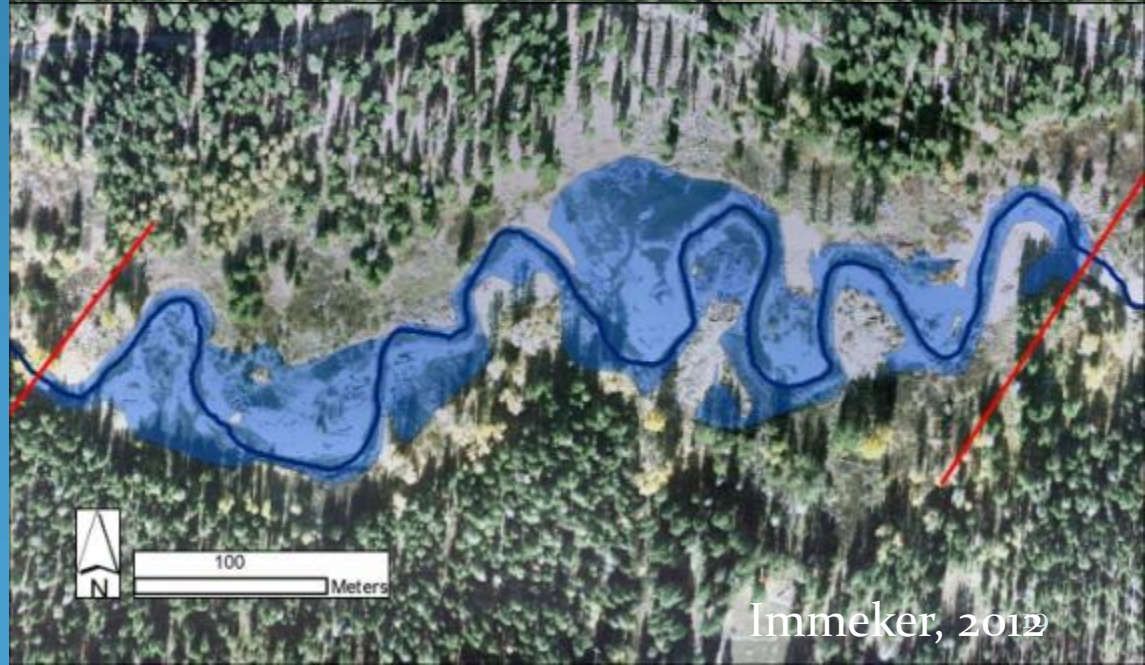
# Results: Hydraulic Improvements

2 year return flow  
of  $10.7 \text{ m}^3/\text{s}$

Pre-Restoration  
 $16,063 \text{ m}^2$

Post-Restoration  
 $32,327 \text{ m}^2$

**101% increase in  
flooded area extent  
40-60% less total  
average shear stress**

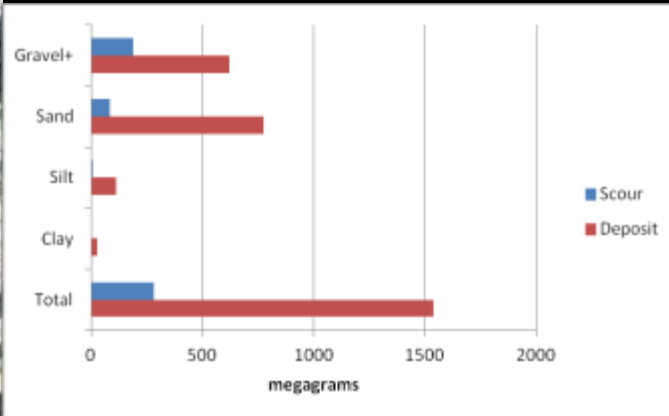
# Results: Sediment Mapping/Sampling

Pre project = - 61 tons fine sediment per eroded per year  
Post project = + 142 tons of fine sediment retained

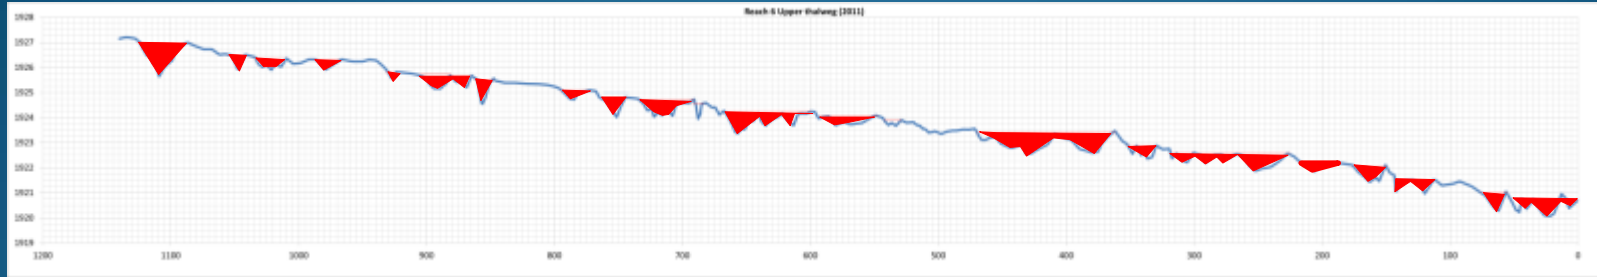
- 95% stable banks
- Pool riffle ratio = 1.9:1
- # pools = 25
- Median pool depth = 0.6m
- 7% riffle fines
- % Shade = 5

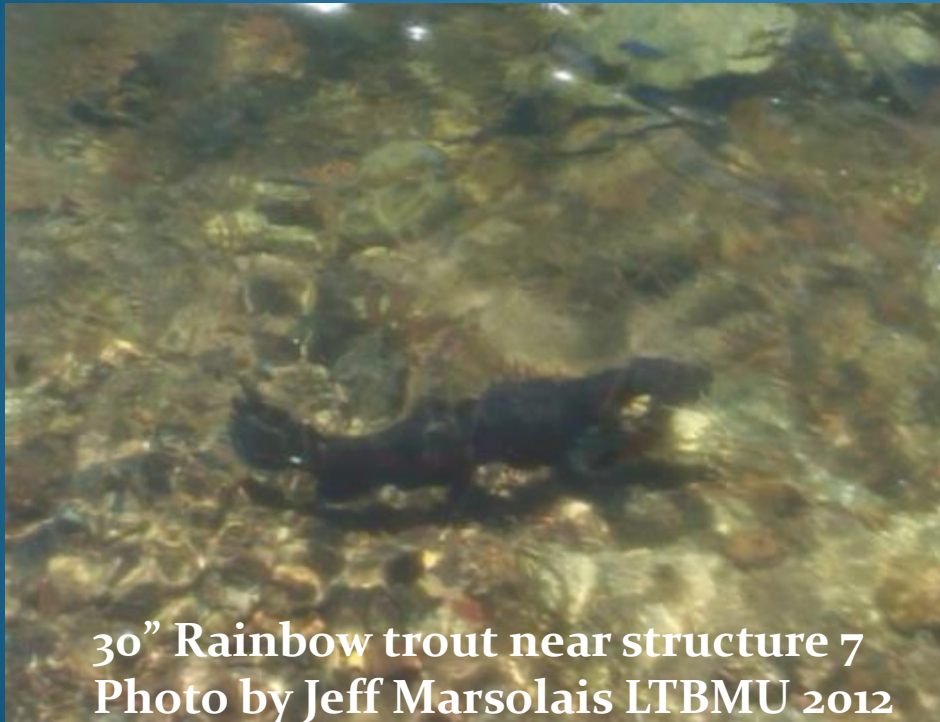
30" Rainbow trout near structure 7  
Photo by Jeff Marsolais LTBMU 2012

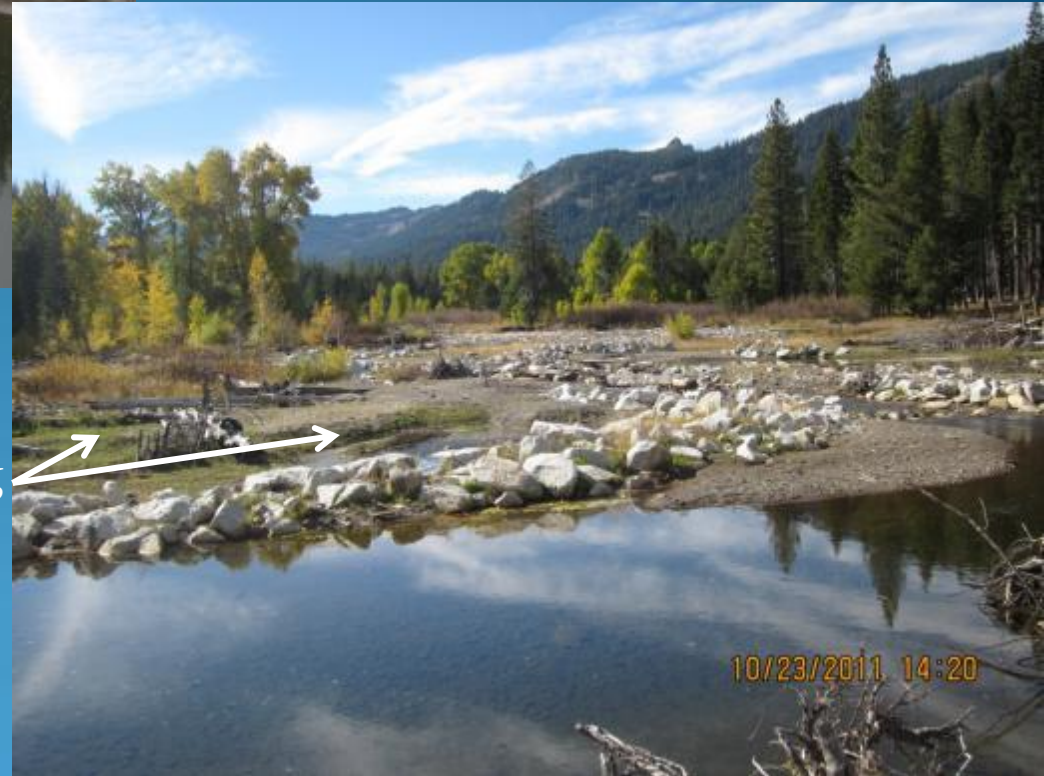
Riparian grasses colonizing  
Fresh flood sediments  
2011..the start
