Cultured Ecology Generation 2: Demonstrating Nutrient and Fine Particle Removal in Tahoe Basin Stormwater

Alan Heyvaert¹
Steve Patterson²
Scott Brown³
John Reuter⁴
Collin Strassenburgh⁴

June 25, 2010

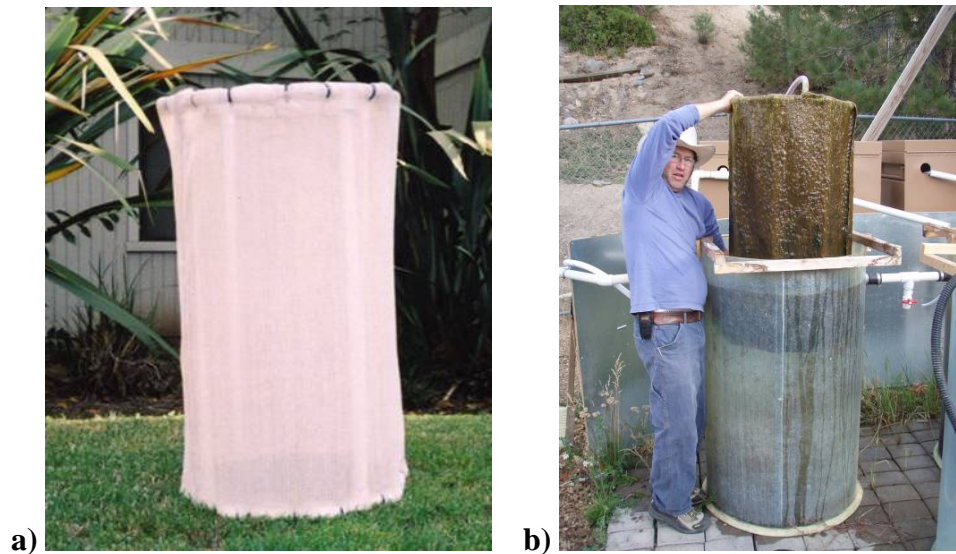
Figure 5. Periphyton substrate screen a) prior to first deployment b) with typical periphyton biofilm before harvesting.

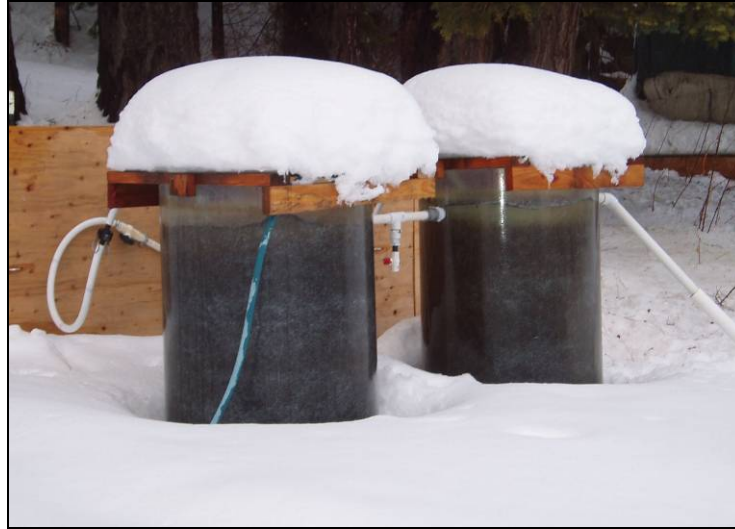
Figure 7. Tanks in snow at TERC field facility in Tahoe City.

Two tanks were established at the TERC field lab in Tahoe City beginning on October 10, 2007 (Figure 7), while permits and permissions to use the Village Boulevard site and electrical power were being obtained. The two tanks were moved to the Village Boulevard site the week of February 14, 2008 and a new third tank added. The three tank system was fully operational at the Village and Country Club site on February 14, 2008. Water quality autosamplers were installed and operational by February 28, 2008.

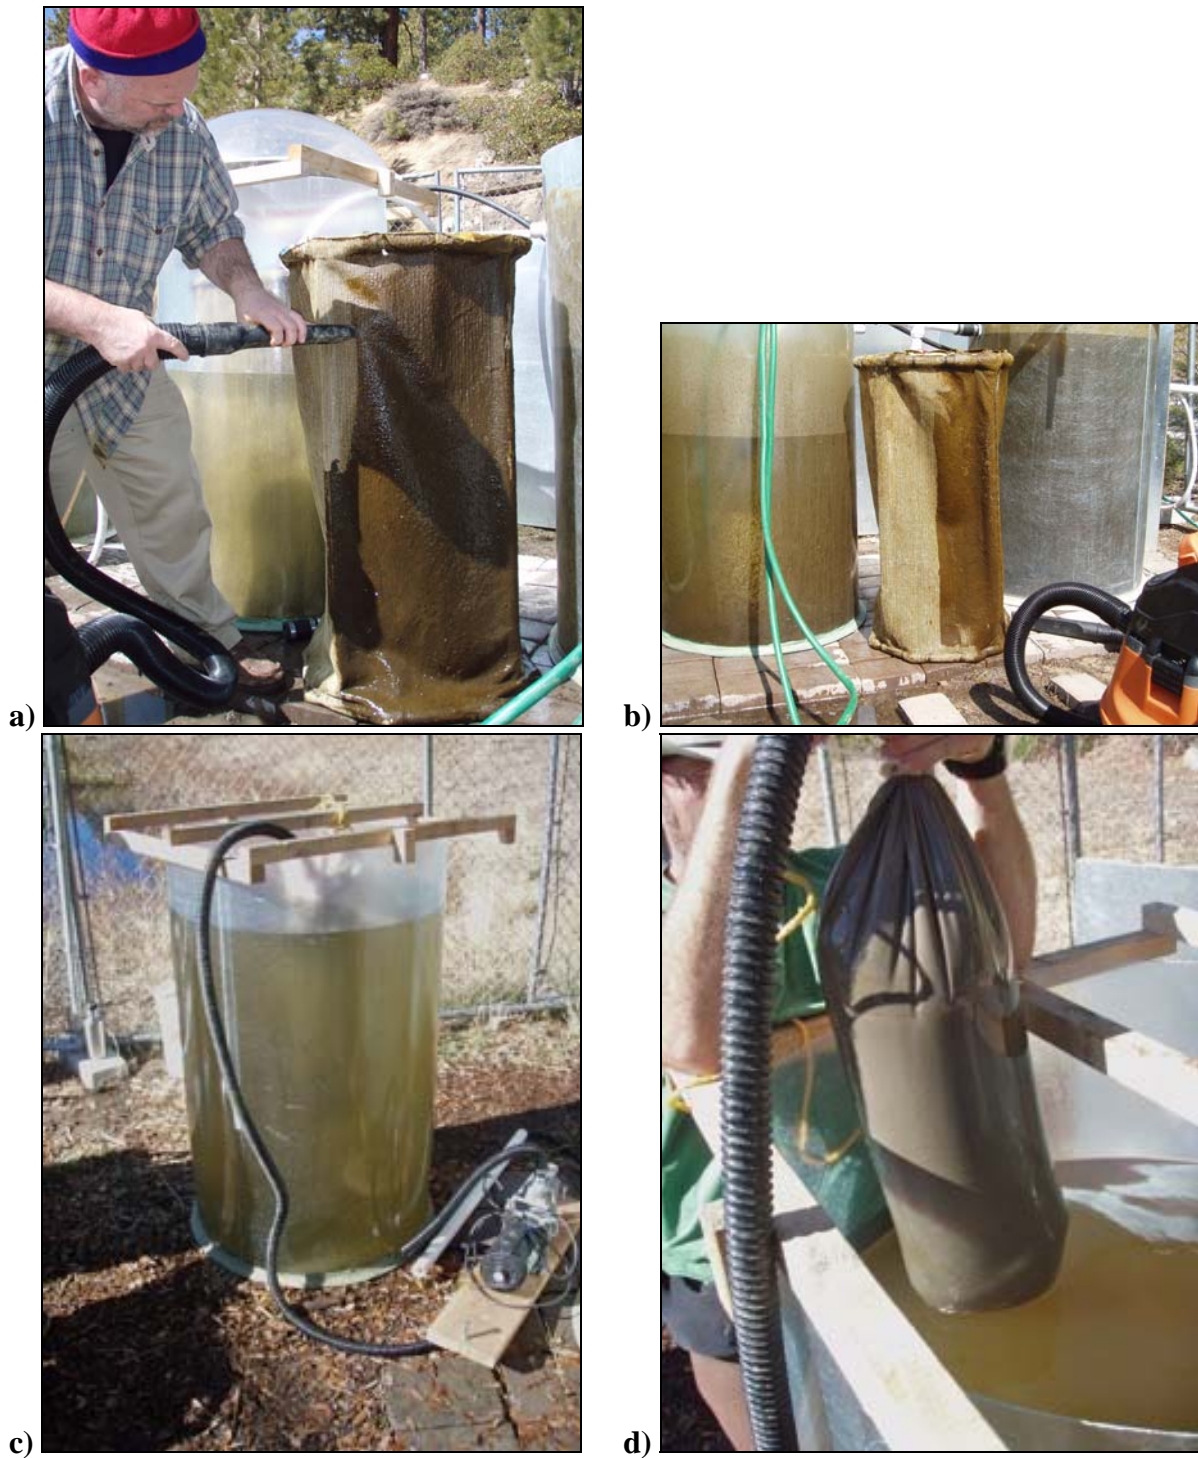
Figure 8. Periphyton harvesting sequence: a) and b) vacuuming biofilm from screen, c) and d) pumping tank water through filter to capture dislodged periphyton.

Once established, periphyton growth was periodically harvested. The period from seeding to growth of first harvestable quantities was approximately four weeks. Following initial establishment, the periphyton was harvested approximately every four weeks. One objective of regular harvesting was to keep the periphyton in an actively growing condition and to remove sequestered nutrients and fine sediment particles from the system. Harvesting removed all periphyton that could be vacuumed from the screens, but sufficient residual material remained in screen crevices to support rapid regrowth.

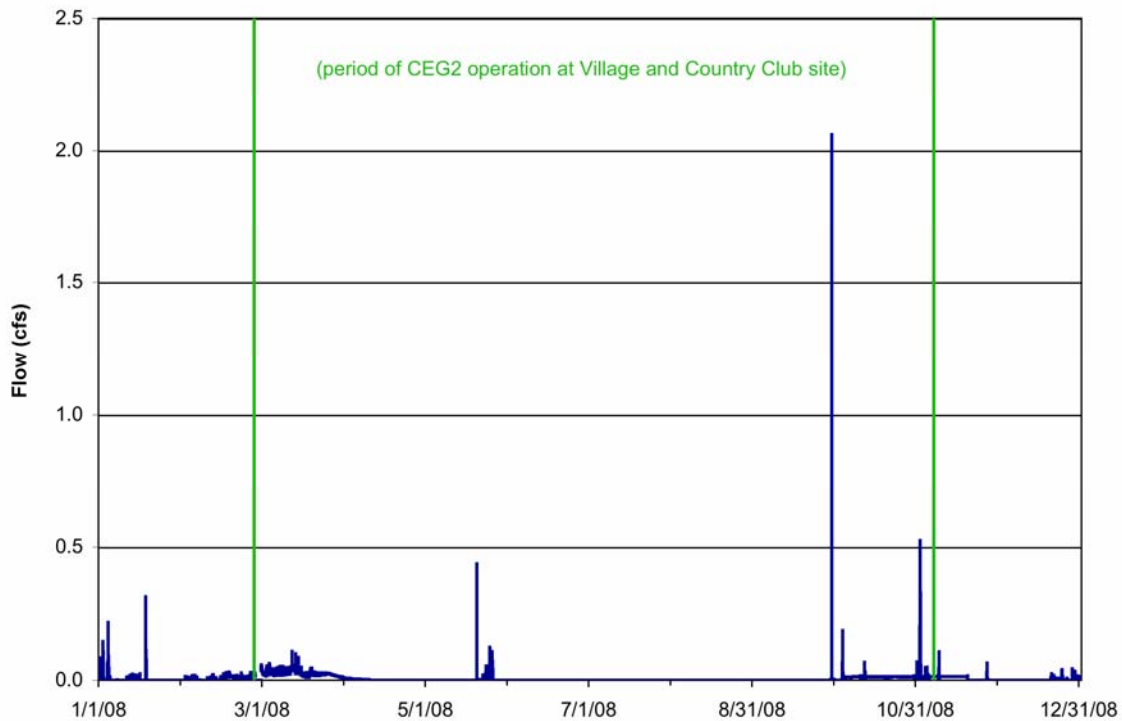
Figure 10. Continuous flow at Northwood site during 2008. Vertical green lines indicate the start and end of monitoring and testing at the Village and Country Club site for CEG2.

The project was set up to test stormwater treatment for two larger runoff events. As with baseflow monitoring, the autosamplers collected sequential samples at each of the four locations, but the individual samples collected during these events were analyzed, rather than just single event composites. Continuous runoff rates for inflow to the treatment pond were not available, but long-term monitoring at an urban stormwater runoff site on Northwood Blvd (NW) less than 1.5 km away provides a general view of runoff patterns throughout the year for this area (Figure 10). From the time at which the periphyton treatment system was first put into operation at Village and Country Club until mid-May, there were no large runoff events at the NW site. A corresponding pattern is evident in the precipitation record from a north state-line meteorological station (NG) less than 6 km distant in Crystal Bay, NV (Figure 11). Generally, more than 0.25 inches of precipitation was required before any substantial runoff was observed at the treatment pond or at the Northwood site.

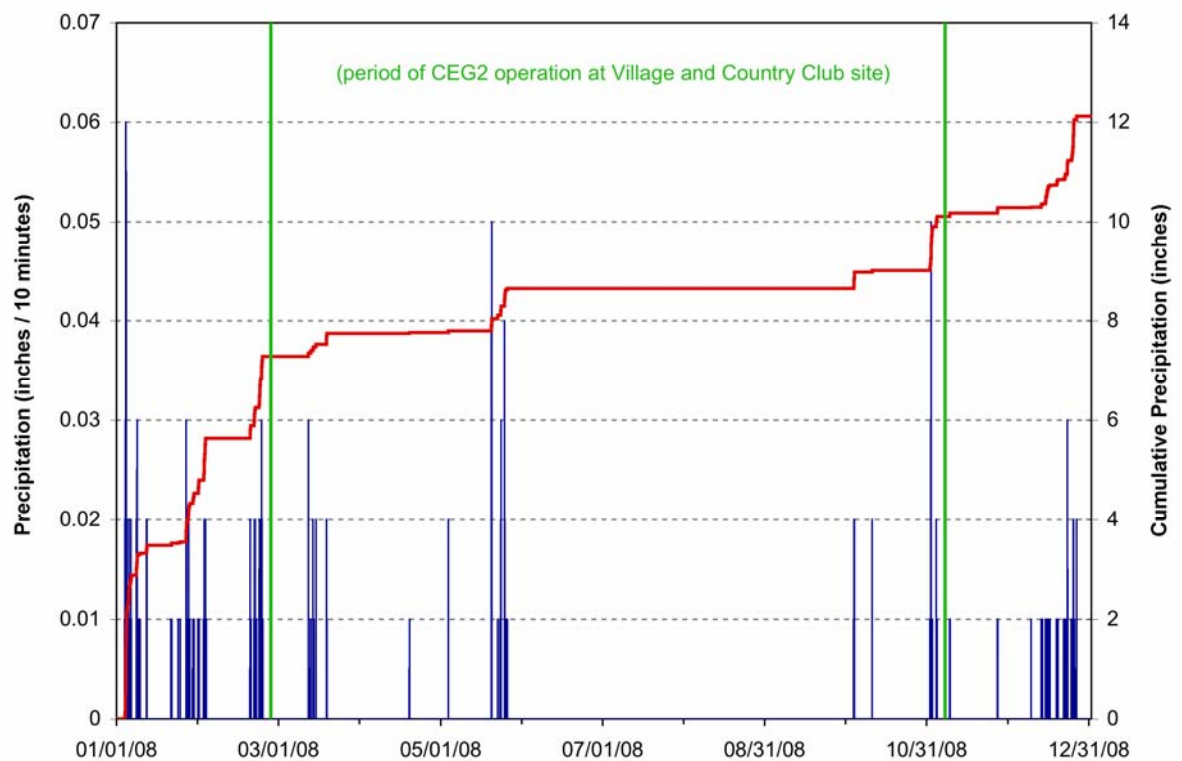
Figure 11. Precipitation intensity and cumulative volume for the north state-line meteorological station (NG) in Crystal Bay, NV. Red line shows cumulative precipitation. Vertical green lines indicate the start and end of periphyton treatment system (CEG2) monitoring and testing at the Village and Country Club site. Blue lines give precipitation intensity.

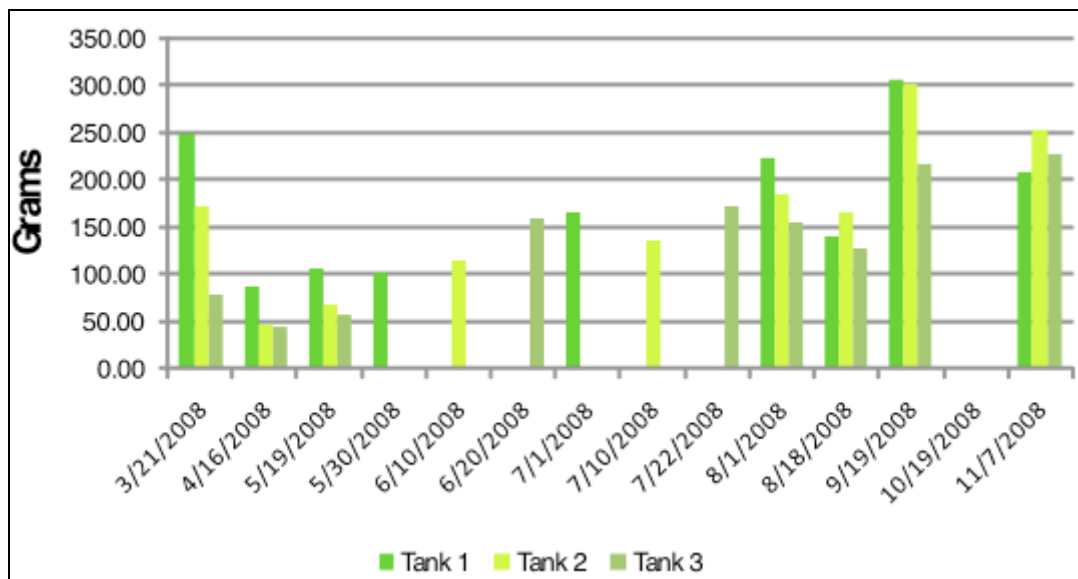
Figure 12. Dry weight of total harvested periphyton mass, shown by harvest date.

Over the course of the nine month demonstration period 4,629 grams (dry weight) of material were harvested (Figure 12). On a per day basis (266 days) the average production was 17.4 g/day. Based on an average phosphorus concentration of 0.24 percent (Table 4), the periphyton harvests removed a total 11.11 grams of phosphorus. The footprint occupied by each tank was approximately 0.46 m², and taken together all three tanks occupied approximately 1.38 m². Therefore, the average system dry mass production of 17.4 g/day was equivalent to 12.6 g/m²/day. In comparison, Adey *et al.* (1993) reported dry biomass production levels of from 15 to 27 g/m²/day in Florida algal turf experiments. The Florida system operated with warmer temperatures, greater average insolation, and without nitrogen limitation.

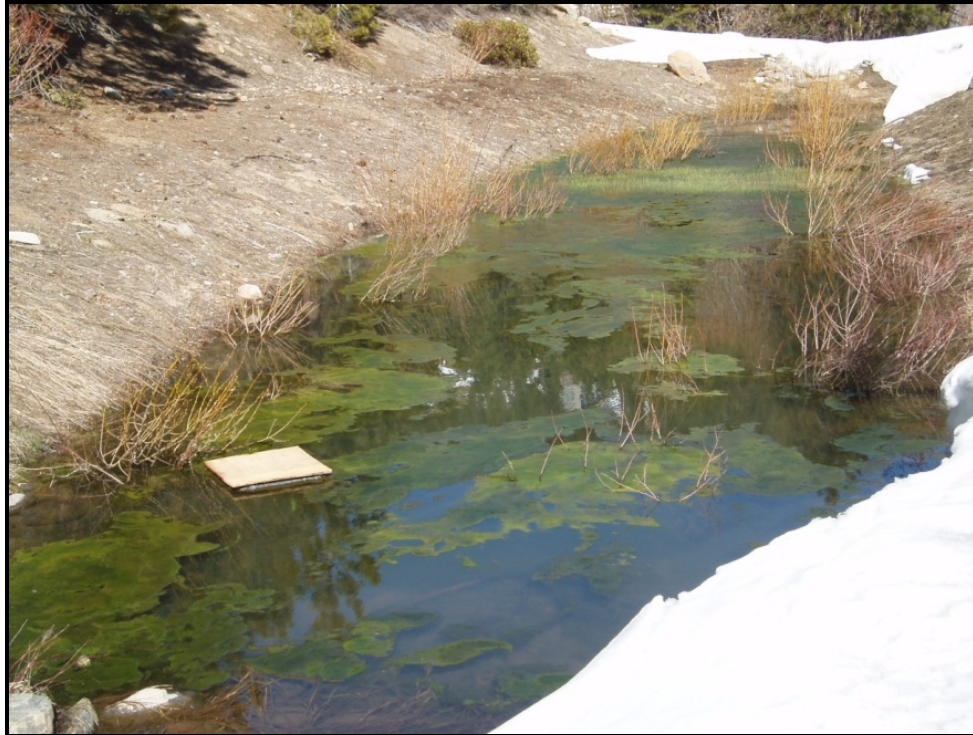
Figure 16. Floating algae production in the source stormwater pond (3-21-09).

As discussed below, the growth of nuisance floating algae in Pond 1 caused various problems for the CEG2 system. For the latter part of the demonstration period, the source water for the system was changed to Third Creek beginning July 25, 2008. This provided cooler water through a gravity feed-line into the first tank without pumping. Subsequent movement through the tanks was the same as previously described, although average flow rate increased about 34% (from 2.11 to 2.83 gal/min).

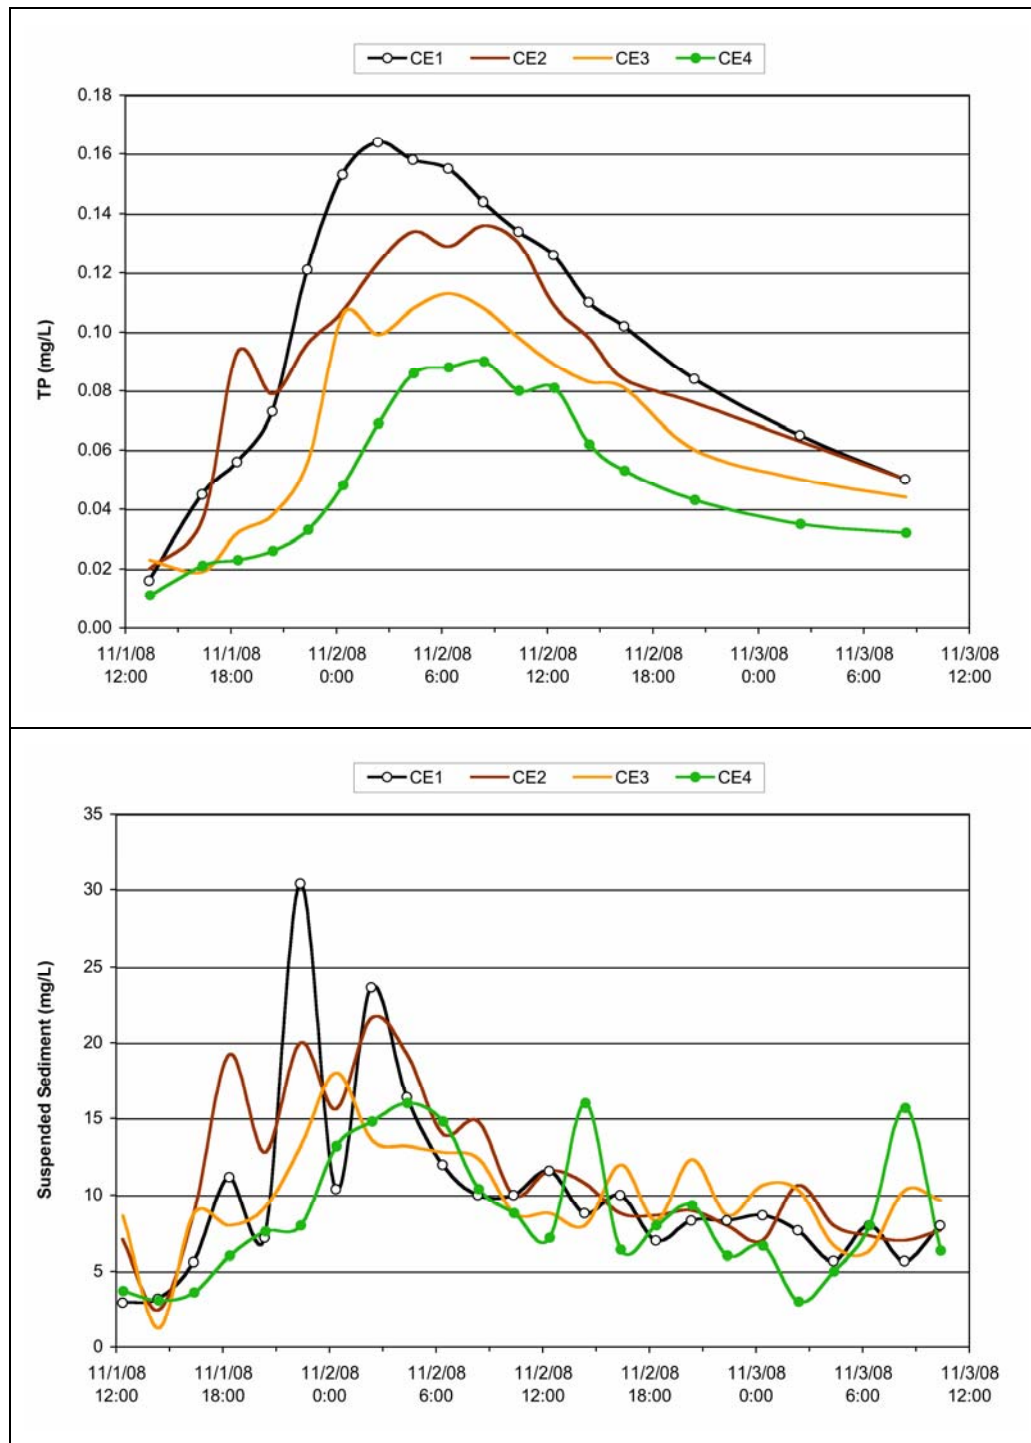
Figure 18. Pollutographs of periphyton treatment during runoff associated with a relatively large rainstorm (0.89 inches) on November 1-2, 2008. Flow was constant through the system at about 9.2 L/min (2.5 gal/min) and discrete samples were taken simultaneously at all four locations.

By contrast, there was a large storm front in early November that produced a sustained pulse of runoff to the stormwater ponds, and constituent concentrations show a clear spike associated with that event. This was exactly what was needed to provide a realistic on-site test of stormwater treatment by the periphyton biofilm system, and monitoring had been extended beyond the project end date in hope of such an opportunity. It had been six weeks since the last harvest (September 19th). Although periphyton growth had slowed somewhat with shorter days and colder temperatures, there was thick layer of biofilm on the screens and tanks ready for treatment testing. This event lasted much longer than the October event. Samples were collected at two hour intervals over a 48 hour period, with each one analyzed for chemical concentrations during the peak of the runoff period (from 16:21 on Nov 1st through 16:24 on Nov 2nd), and a sufficient number analyzed during the long trailing limb of the runoff period to complete the picture (see Appendix E). Pollutographs from this event are easier to interpret than they were from the October event, with obviously decreasing concentrations of TP, TDP, SRP and nitrate at each additional treatment tank. This suggests that more tanks or treatment surface area could have provided additional benefit. Although it was not feasible to add more tanks in this demonstration scale project, it might be a useful optimization procedure in future tests to assess the lowest practical concentrations attainable with a fully functional periphyton biofilm system.

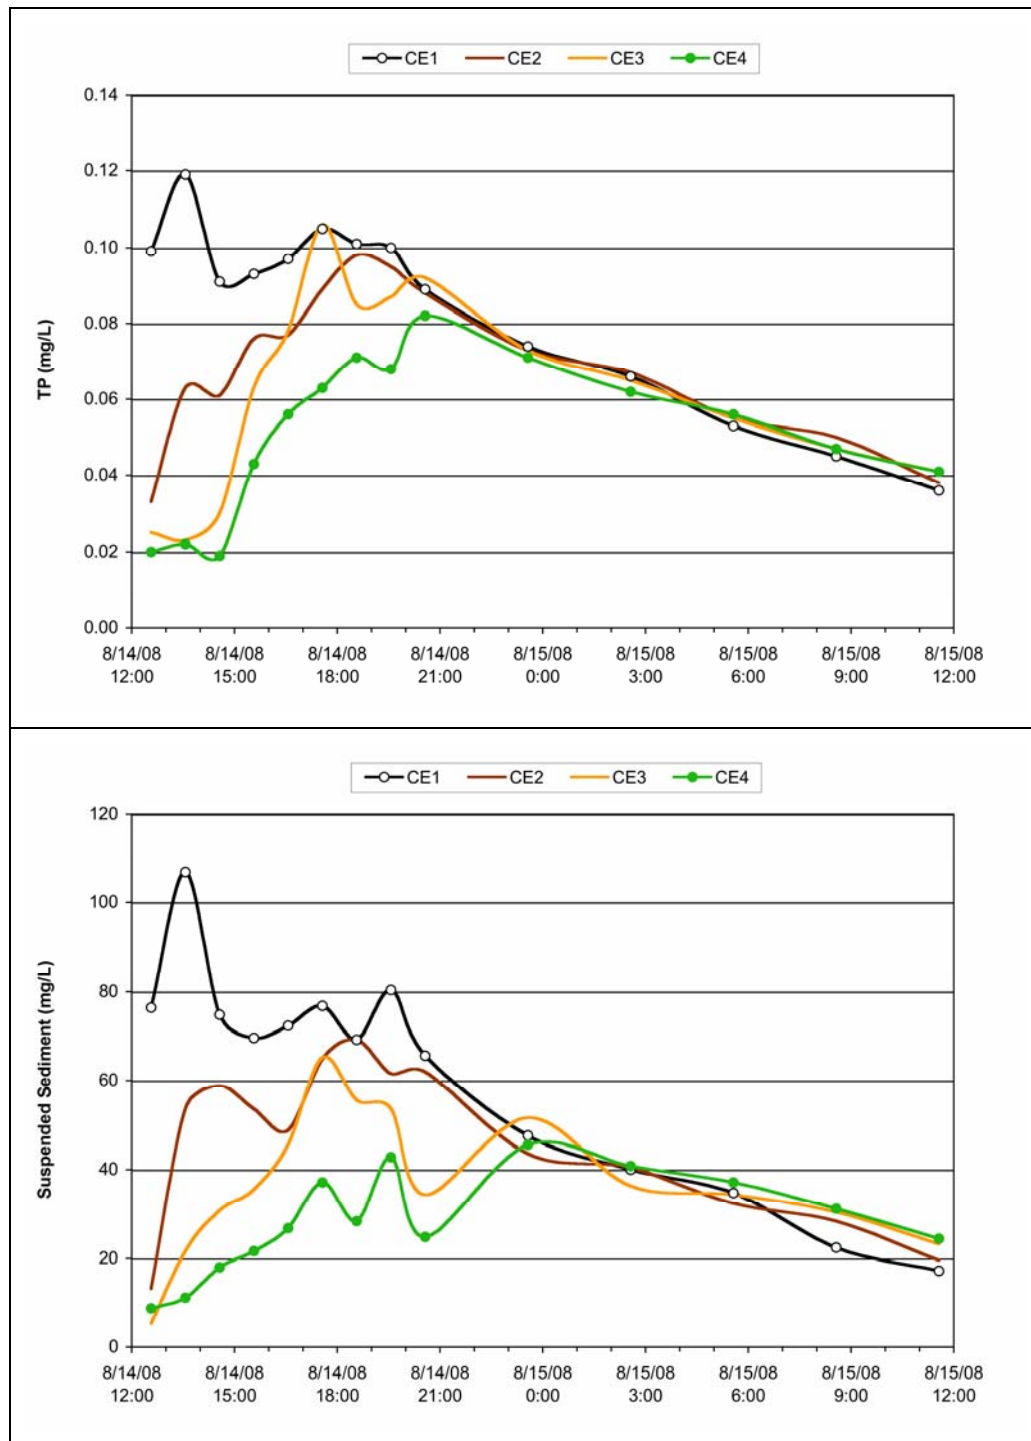
Figure 20. Simulated runoff experiment on August 14th, created by stirring pond sediments on hourly intervals over an eight hour period and sampling at all four points every hour for the first eight hours and every three hours thereafter. Flow was constant through the system at 10 L/min (2.6 gal/min). Discrete samples were taken simultaneously at all four locations.

In the first experiment, conducted on August 14th, the bottom sediments of the Pond 1 were disturbed to enhance pond water concentrations of nutrients and fine sediment particles. Since this bottom material was in large part derived from the settling of particles delivered during past stormwater events, it was believed that the water quality conditions created would reflect to some degree the characteristics of stormwater runoff typically observed at the site. Initial agitation consisted of bottom sediments lifted with a rake followed by stirring to fully mix the pond water. This was repeated every hour for eight hours in an attempt to maintain relatively consistent conditions within the pond during the experiment. Water quality sampling occurred at all four sites in the system every hour during the first eight hours and then on three-hour intervals during the next 15 hours. Each sample was analyzed individually without compositing. More details about this experiment are shown in Appendix B.
